# Road Safety Audit

## Summit Point Road

Shirley Road to Lloyd Road  
Jefferson County, West Virginia

**December 11, 2018**

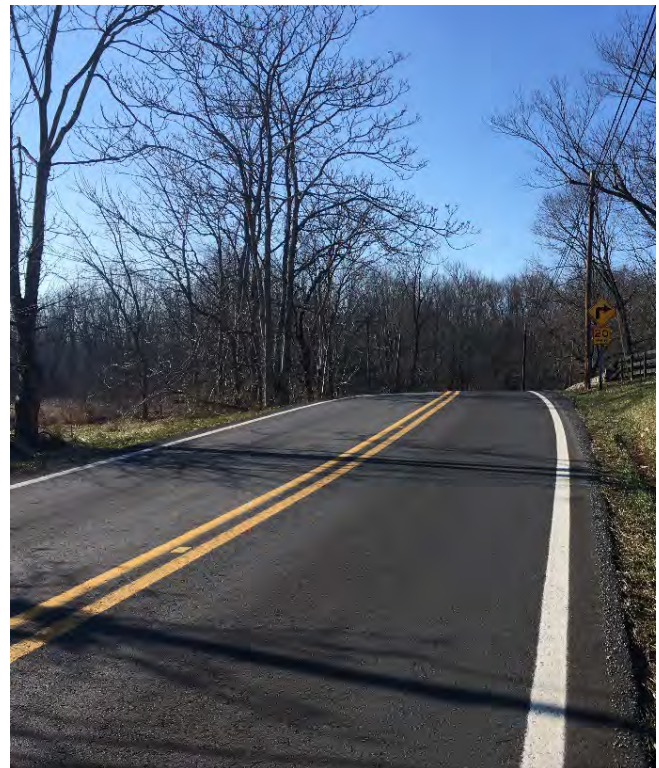
1.1	Motorists are Driving Too Fast
<b>Observations</b>	
<p>The general perception is that motorists are going too fast for available sight distances (vertical and horizontal)</p> <p>Based on crash data from 2013 to 2017, 71% of the reported crashes throughout the section were single vehicle crashes. 87% of those crashes were run off the road/hit fixed object crashes (embankment, fence, pole, tree, roll-over).</p>	
<b>Suggestions</b>	
<p><i>Short-term</i></p> <ul style="list-style-type: none"> <li>• Conduct speed study (using ball-bank indicator) and vertical curve sight distance study</li> <li>• Reduce speed limit</li> </ul>

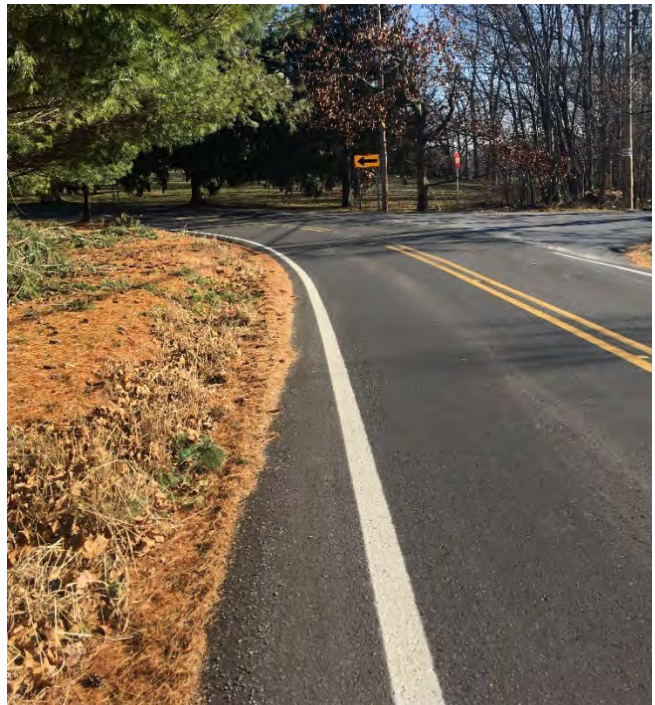
<b>2.1</b>	<b>Sight Distance at Summit Point Road/Lloyd Road Intersection</b>
<b>Observations</b>	
Sight distance issue at the Summit Point Road/Lloyd Road intersection	
Based on crash data from 2013 to 2017, 23% of the reported crashes along the corridor occurred at this intersection. 60% of those crashes being either right-angle or head-on.	
<b>Suggestions</b>	
<i>Short-term</i>	
<ul style="list-style-type: none"> <li>Advanced intersection sign (W2-2) with distance plaques (W16-2aP)</li> </ul>	
<i>Long-term</i>	
<ul style="list-style-type: none"> <li>Consider widening and reprofiling roadway</li> </ul>

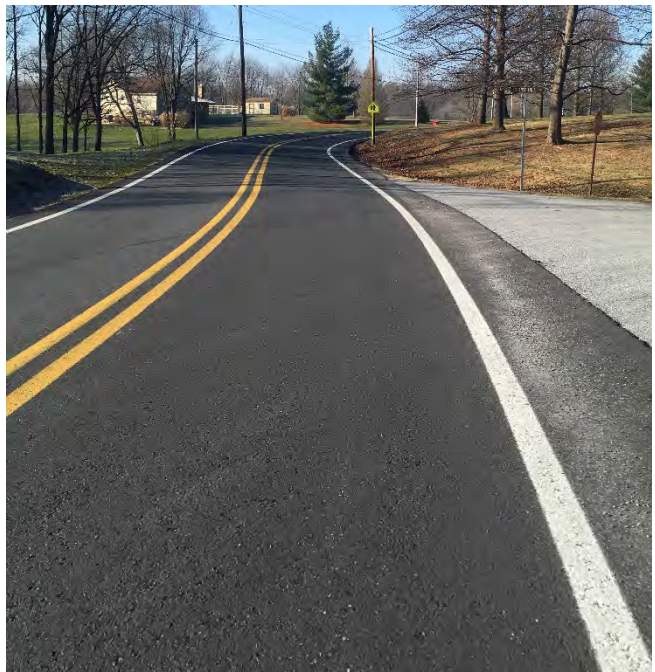
<b>2.2</b>	<b>Sight Distance at Summit Point Road/Locust Hill Road Intersection</b>
<b>Observations</b>	
Sight distance issue at the Summit Point Road/Locust Hill Road intersection	
Picture taken facing west at Locust Hill Drive/Summit Point Road intersection	
<b>Suggestions</b>	
<i>Short-term</i>	
<ul style="list-style-type: none"> <li>Advanced intersection sign (W2-2) with distance plaques (W16-2aP)</li> </ul>	
<i>Long-term</i>	
<ul style="list-style-type: none"> <li>Consider widening and reprofiling roadway</li> </ul>

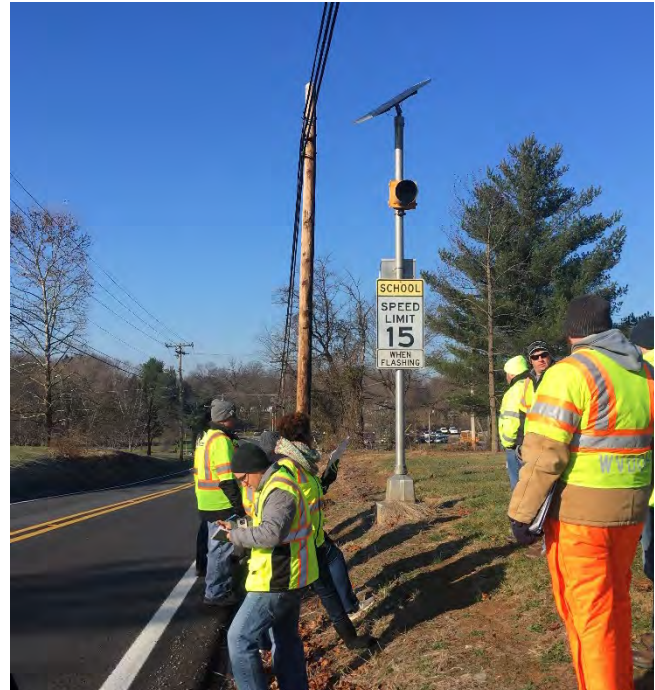
### 3.1 Queueing on Summit Point Road

Anecdotal evidence indicated that heavy traffic volumes utilize school driveways at the beginning of the school year. Queueing on Summit Point Road is a resulting problem

The picture shows the current westbound school zone flasher along Summit Point Road. Based on crash data from 2013 to 2017, 83% of the reported crashes through the school zone were single vehicle (hit animal or run off the road) crashes.

- Upgrade school zone flashers(S5-1)
- Provide additional signing and pavement markings

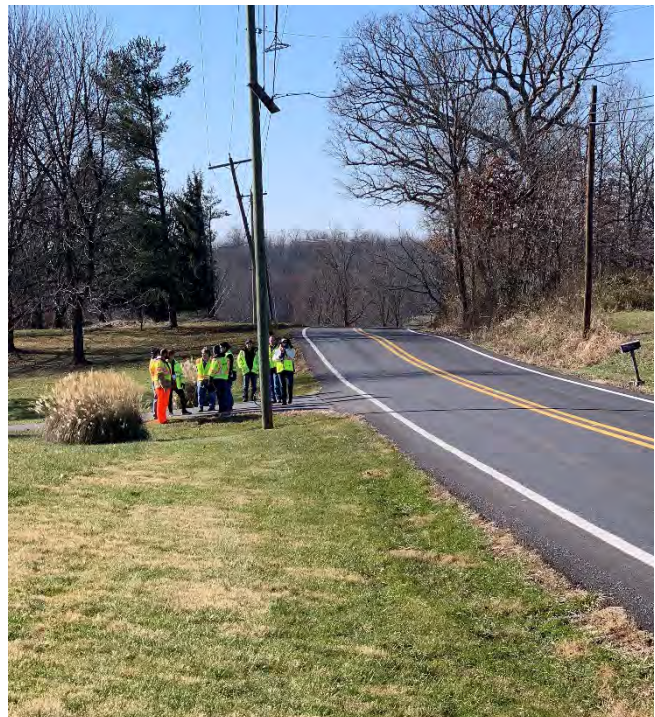
### 3.2 Universal Sight Distance Issues for Driveways

Remainder of driveways with low volumes resulted with no notable concerns other than universal sight distance issues associated with the entire study area

- Conduct speed study
- Reduce speed limit

- Consider removing roadside obstructions/vegetation within clear zone

- Consider widening and reprofiling roadway to meet current typical sections

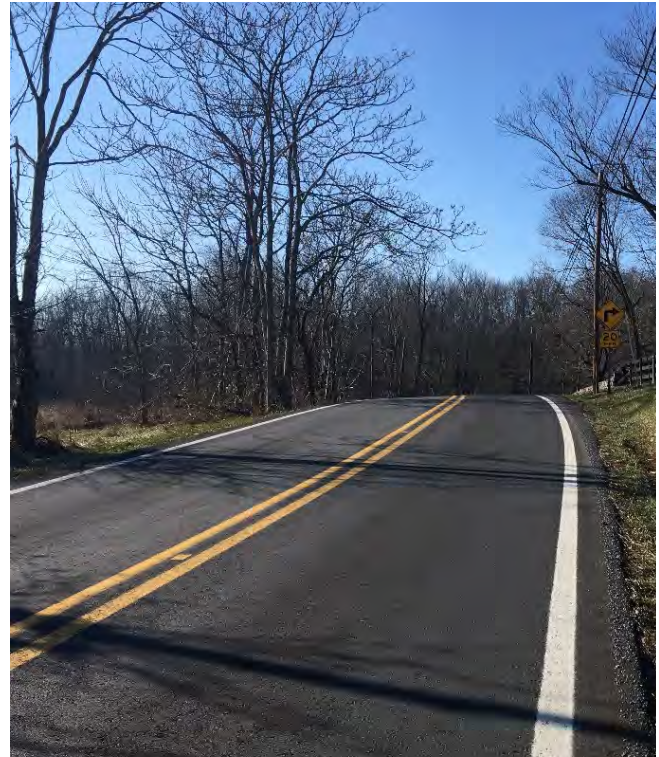
### 4.1 Drivers Unfamiliar with the Roadway

Anecdotal evidence suggests that Summit Point Road is frequently used to access Summit Point Motor Sports Park; resulting in an expectation that the traffic mix includes many drivers that are unfamiliar with the roadway geometry, especially on weekends

Based on crash data from 2013 to 2017, 43% of the reported crashes within the study section occurred on the weekend. 89% of those crashes occurred in wet road conditions.

- Reduce speed limit
- Additional/revised signing and pavement markings

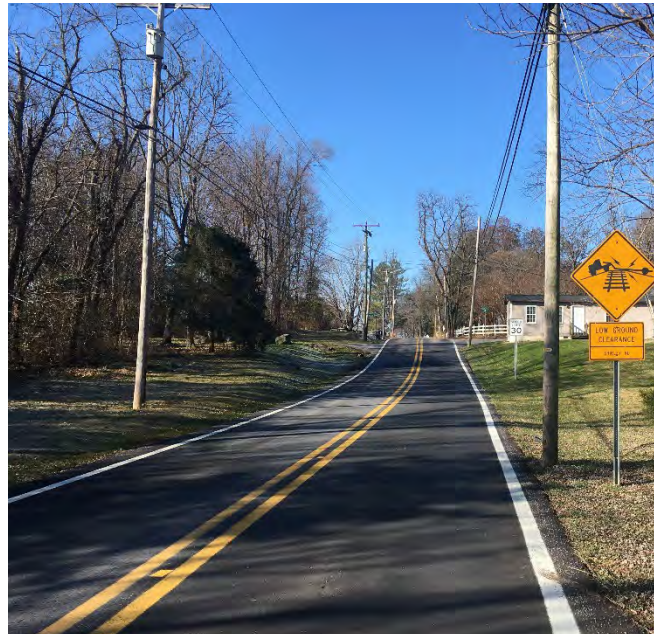
1.1	Narrow Lanes and No Shoulders
<b>Observations</b>	
<p>Very narrow lanes and no shoulders</p> <p>Based on crash data from 2013 to 2017, 71% of the reported crashes throughout the section were single vehicle crashes. 87% of those crashes were run off the road/hit fixed object crashes (embankment, fence, pole, tree, roll-over)</p>	
<b>Suggestions</b>	
<p><i>Long-term</i></p> <ul style="list-style-type: none"> <li>Consider widening and reprofiling to meet current typical sections</li> </ul>

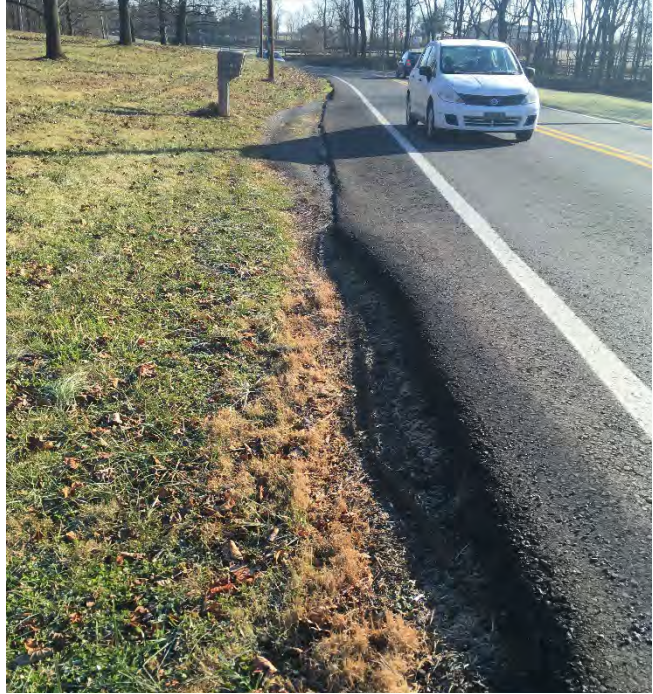
<b>1.2</b>	<b>Roadway Resurfaced with Skid Resistant Mix</b>
<b>Observations</b>	
<p>Roadway resurfaced recently with skid resistant mix</p> <p>Based on crash data from 2013 to 2017, 69% of the reported crashes through the section occurred in wet conditions and 62% of the reported crashes were run-of-the-road crashes.</p>	
<b>Suggestions</b>	
<p><i>Intermediate-term</i></p> <ul style="list-style-type: none"> <li>• Add safety edge during next resurfacing</li> </ul>

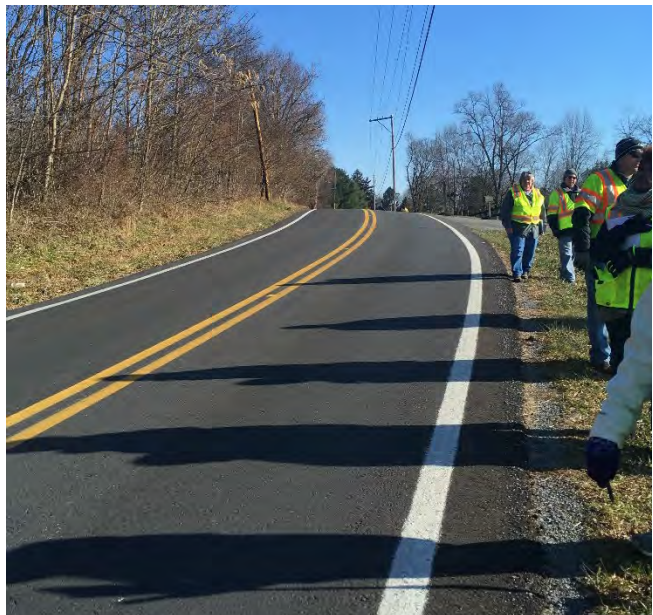
<b>1.3</b>	<b>Vertical and Horizontal Curves</b>
<b>Observations</b>	
<p>A large portion of the study section includes vertical and/or horizontal curves</p>	
<b>Suggestions</b>	
<p><i>Short-term</i></p> <ul style="list-style-type: none"> <li>• Additional curve signage</li> </ul>

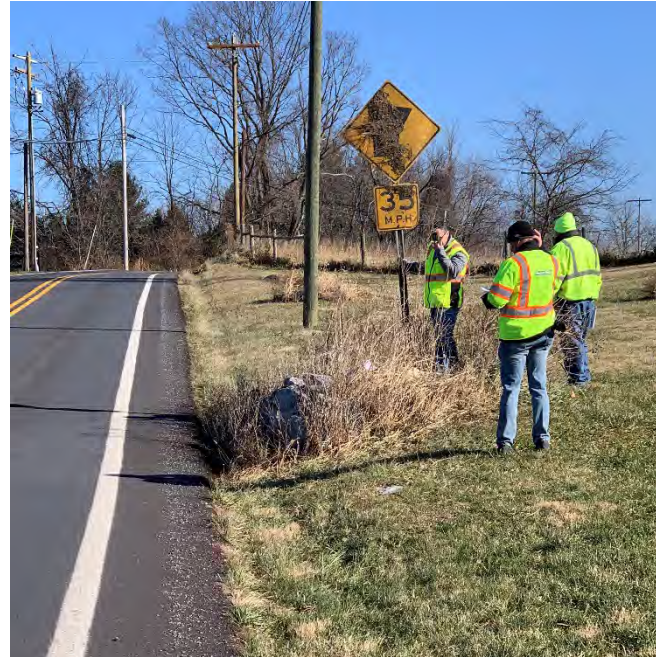
**1.4 Advisory Reduced Speed Limit Signs**

A large portion of the study section is posted with and/or should be posted with advisory reduced speed limit signs associated with curves or sight distance

- Reduce speed limit

- Add High Friction Surface Treatment (HSFT) to curves with wet weather crash history

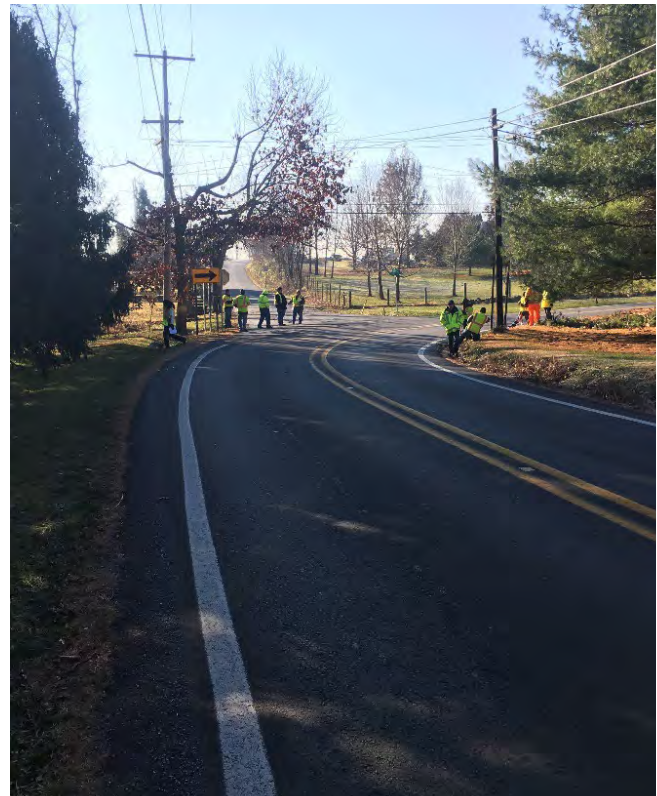
**1.5 Lloyd Road Curve Area**

Lloyd Road intersects with Summit Point Road in a sharp curve, creating sight distance issues and confusion to drivers traveling southbound on Summit Point Road

Based on crash data from 2013 to 2017, 23% of the reported crashes along the corridor occurred at this intersection. 60% of those crashes being either angle or head-on.

- Revise and/or provide additional signing and pavement markings

- Add intersection street lighting
- Add High Friction Surface Treatment (HSFT)

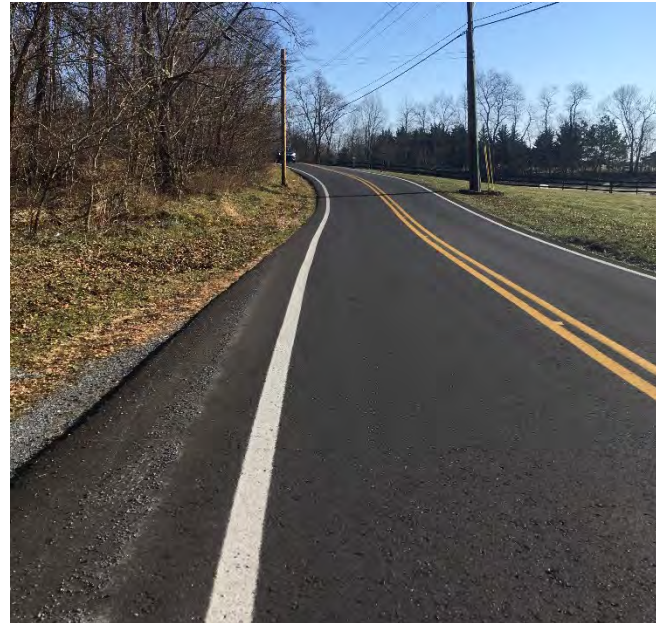
**1.6 Locust Hill Drive Intersection Area**

Locust Hill Drive intersects with Summit Point Road between two horizontal curves, creating sight distance issues for drivers turning in/out of Locust Hill Drive

Picture taken facing east from Locust Hill Drive/Summit Point Road intersection.

- Revise and/or provide additional signs

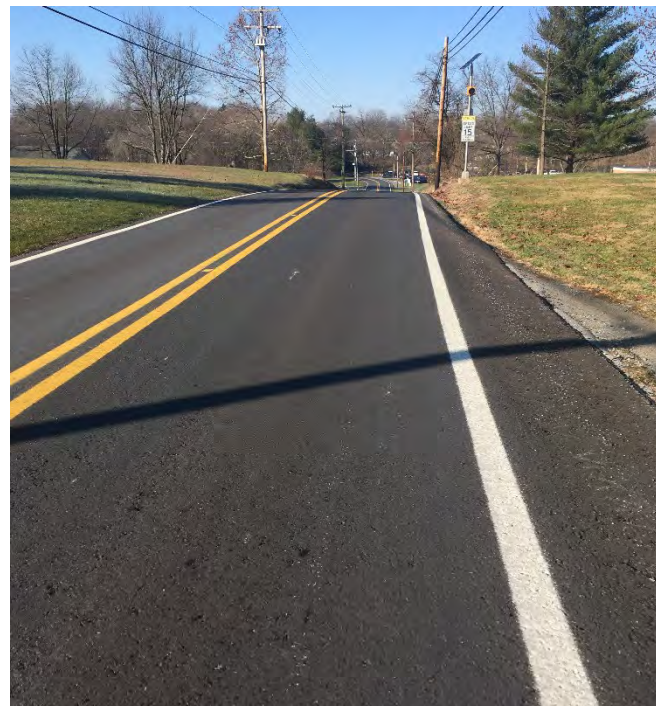
**1.7 South Jefferson Elementary School Zone Area**

The South Jefferson Elementary School is located within a vertical crest curve and a horizontal curve. School zone flashers are out of date.

Based on crash data from 2013 to 2017, 83% of the reported crashes through the school zone were single vehicle (hit animal or run off the road) crashes.

- Update existing school zone flashers
- Add advance school zone flashers
- Provide additional signing and pavement markings

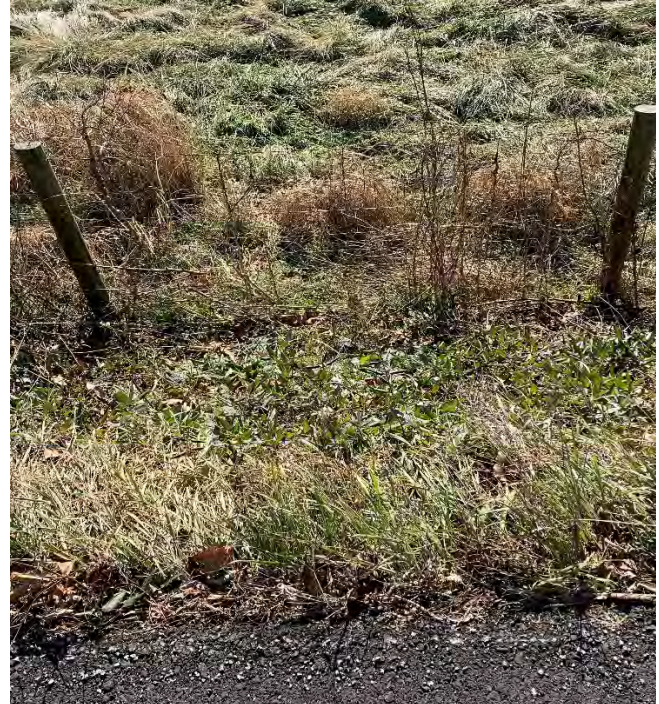
**1.8 West of the School to McCormack Lane**

McCormack Lane intersects with Summit Point Road

Based on crash data from 2013 to 2017, 100% of the reported crashes in the vicinity of the McCormack Lane intersection were single vehicle (hit animal or run-off-the-road) crashes and occurred at night.

- Revise and/or provide additional signs

- Add guiderail along drop-offs west of Pembroke Way

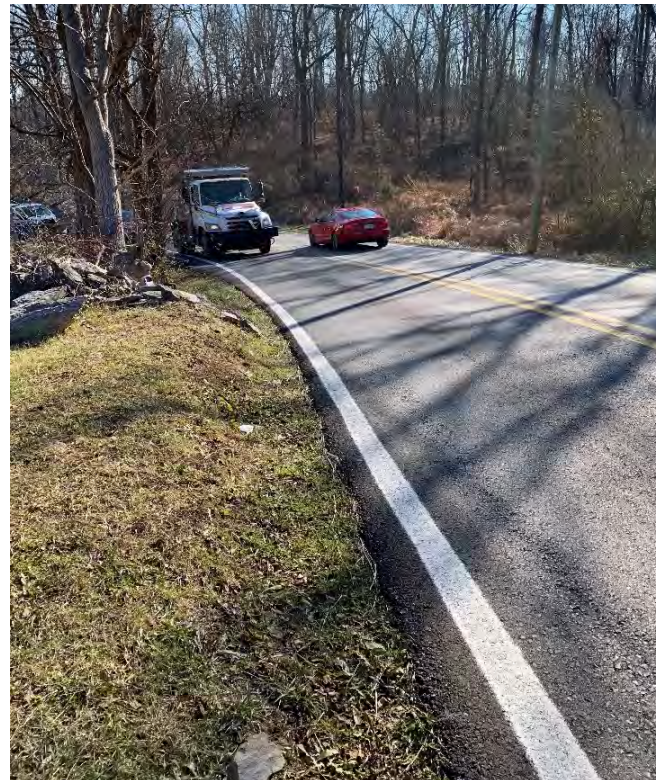
**1.9 Section Adjacent to White House Farm**

Windy/rolling section of roadway limits sight distance throughout area adjacent to White House Farm

Based on crash data from 2013 to 2017, 100% of the reported crashes in the curves around White House Farm were single vehicle (hit embankment, tree, other fixed object) crashes and in the eastbound direction.

- Revise and/or provide additional signs and pavement markings

- Add High Friction Surface Treatment to curves

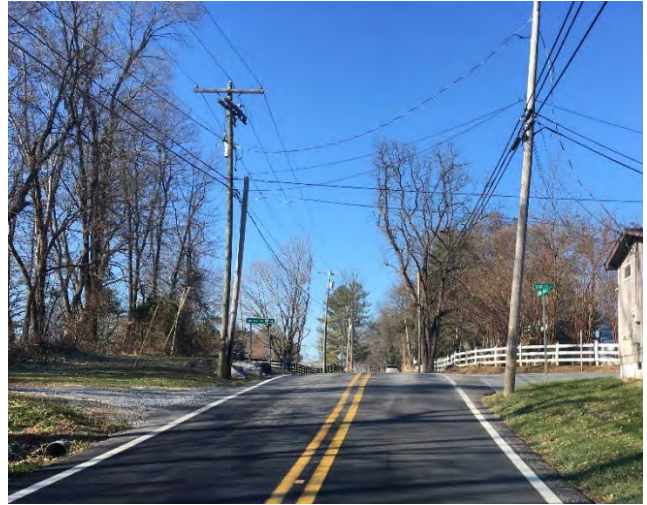
<b>1.10</b>	<b>Shirley Road Intersection</b>
<b>Observations</b>	
Summit Point has a low ground clearance at the point where Shirley Road intersects. Limited sight distance for vehicles turning onto Summit Point Road from Shirley Road.	
<b>Suggestions</b>	
<i>Short-term</i>	
<ul style="list-style-type: none"> <li>Revise and/or provide additional signs</li> </ul>

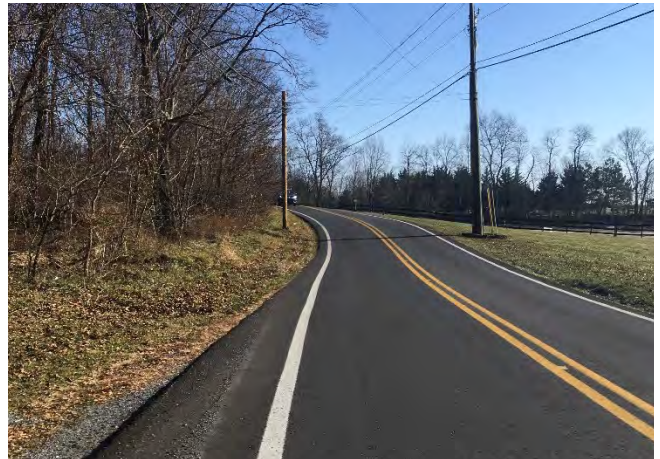
<b>2.1</b>	<b>No Shoulders</b>
<b>Observations</b>	
Sections of roadway with no shoulders	
<b>Suggestions</b>	
<i>Intermediate-term</i>	
<ul style="list-style-type: none"> <li>Add shoulder stone</li> </ul>

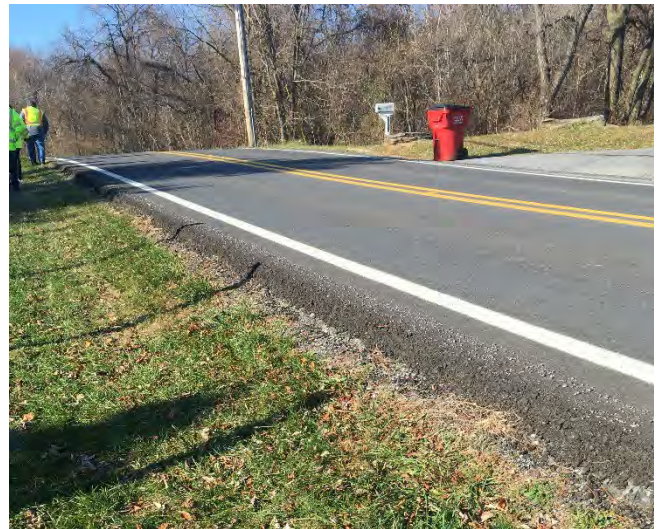
<b>2.2</b>	<b>Pavement Edge Drop-off</b>
<b>Observations</b>	
Greater than 3" pavement edge drop-off throughout the section	
<b>Suggestions</b>	
<i>Intermediate-term</i>	
<ul style="list-style-type: none"> <li>Add shoulder stone</li> <li>Add safety edge during next resurfacing</li> </ul>

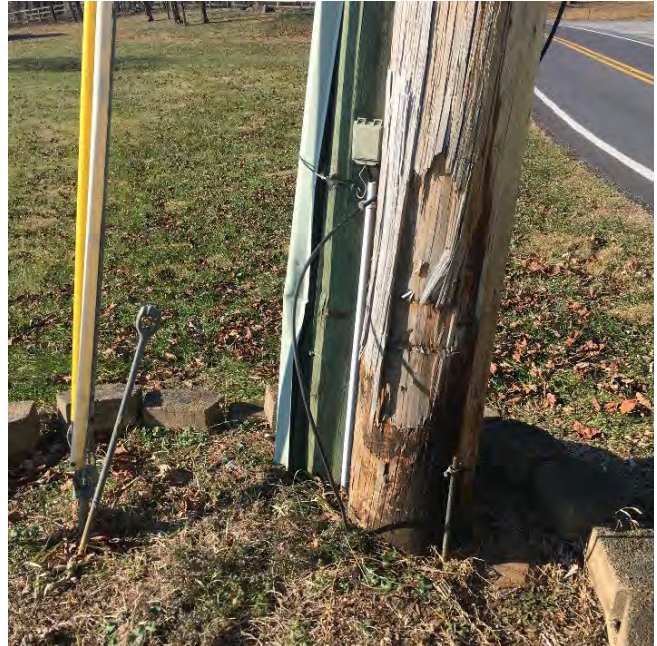
**2.3 Vegetation and Fixed Objects**

Vegetation and fixed objects (trees, poles, fences) along the corridor in close proximity to the roadway. Many exhibited signs of having been hit.

- Delineate fixed objects that are close to the roadway using post mounted delineators or retro-reflective tape as appropriate

- Consider removing trees and other fixed objects that are within the clear zone

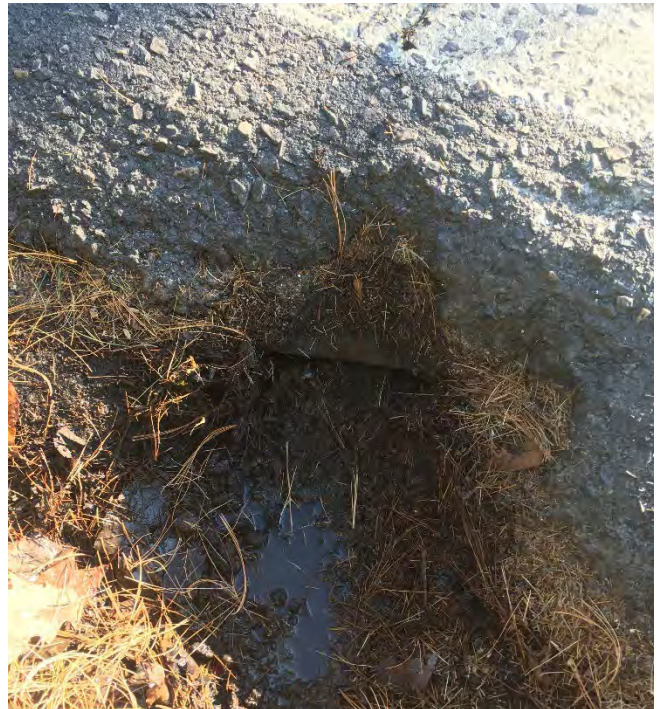
**2.4 Drainage Ditch**

Drainage ditches close to roadway edge in many locations

- Adjust/relocate ditches farther from pavement edge
