Foxcroft Avenue
Pedestrian Road Safety Assessment
Martinsburg, WV

December 3-4, 2019

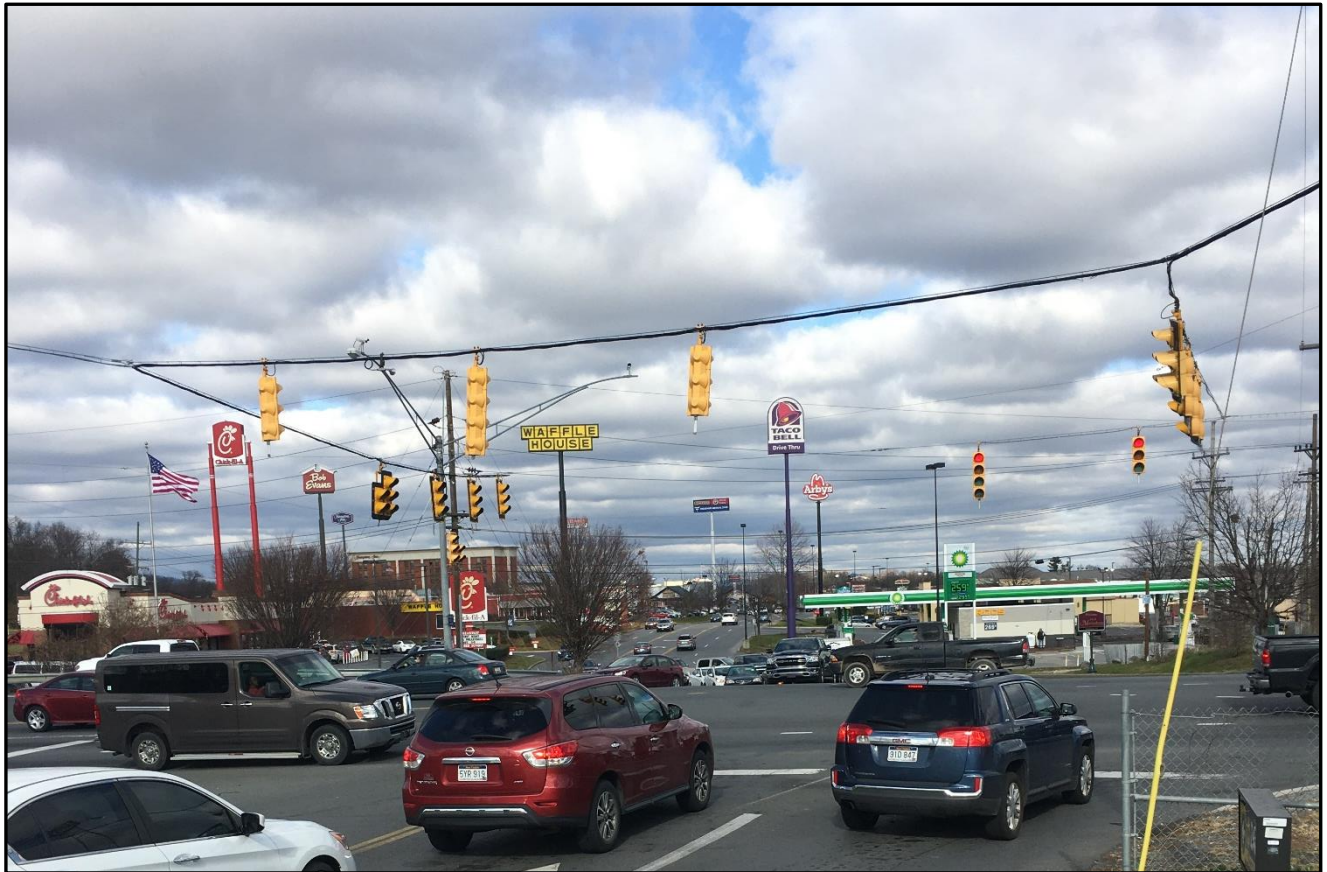
Photo taken looking north on Foxcroft Avenue from the intersection with Apple Harvest Drive. Signs of typical highway commercial businesses can be seen along Foxcroft.

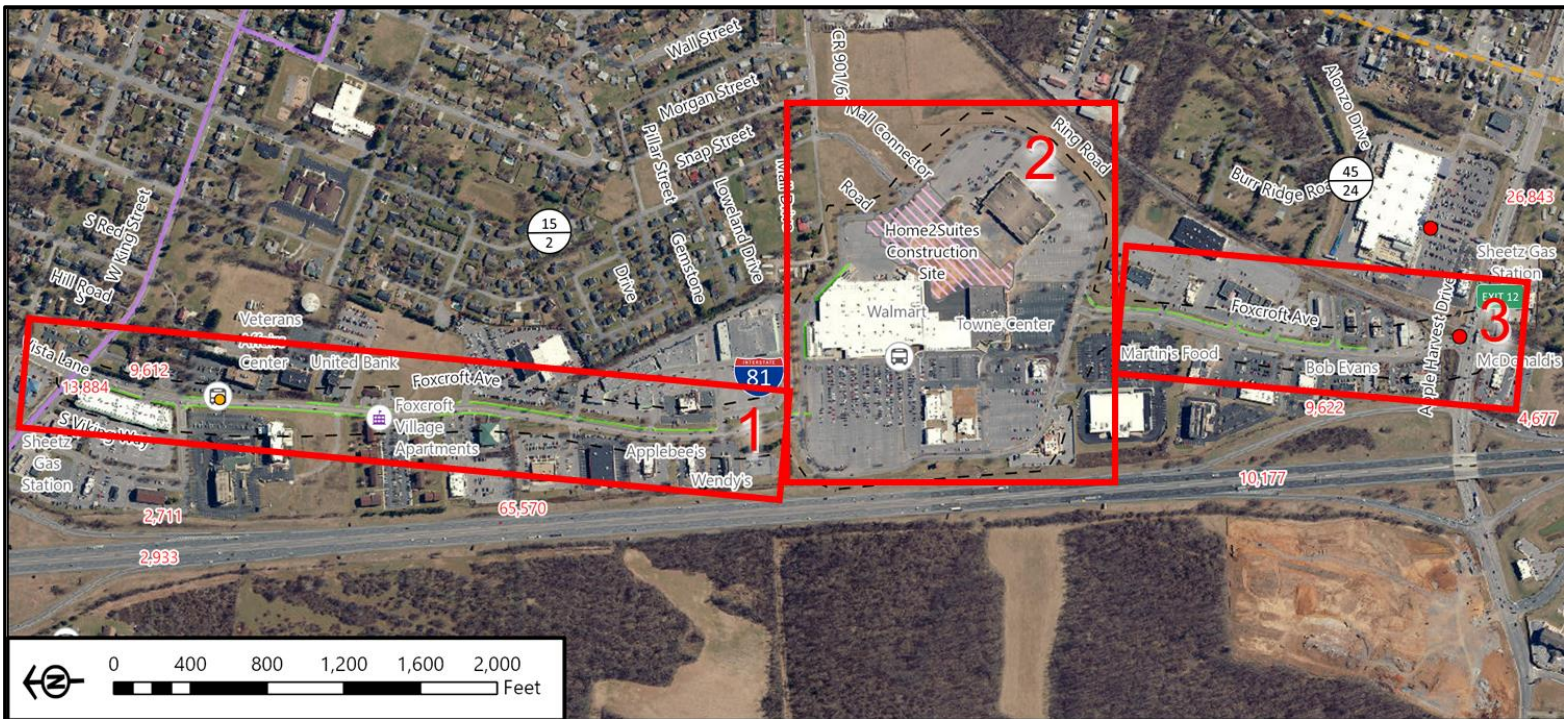
Figure 1 illustrates the general location of the corridors.

Figure 1. Aerial photo of general locations of the RSA corridors.

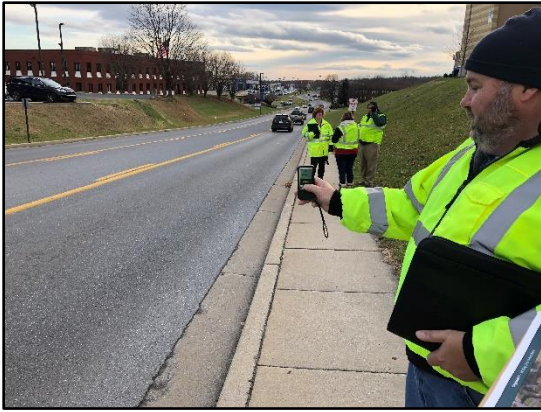
Left: RSA team participants measure vehicle speeds on the northern end of the corridor.

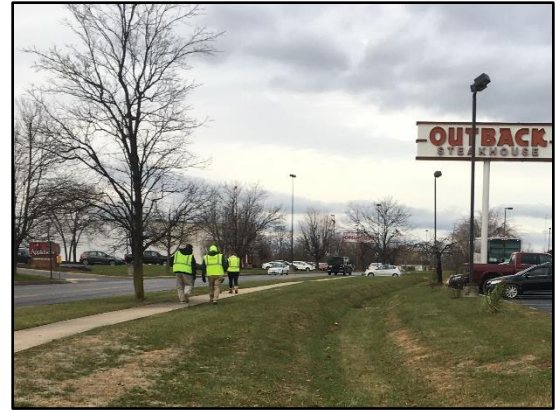
Right: RSA team members use existing sidewalk to walk north on Foxcroft Avenue.

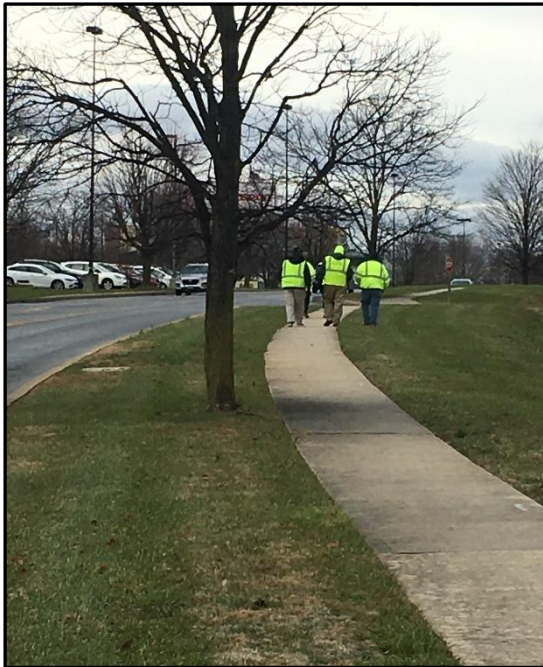
Left: There is a basic sidewalk network, with sidewalk on one side of the roadway along most of Foxcroft Ave. Right: There are light fixtures along the entire corridor, and they provide sufficient levels of pedestrian-focused illumination when functioning.

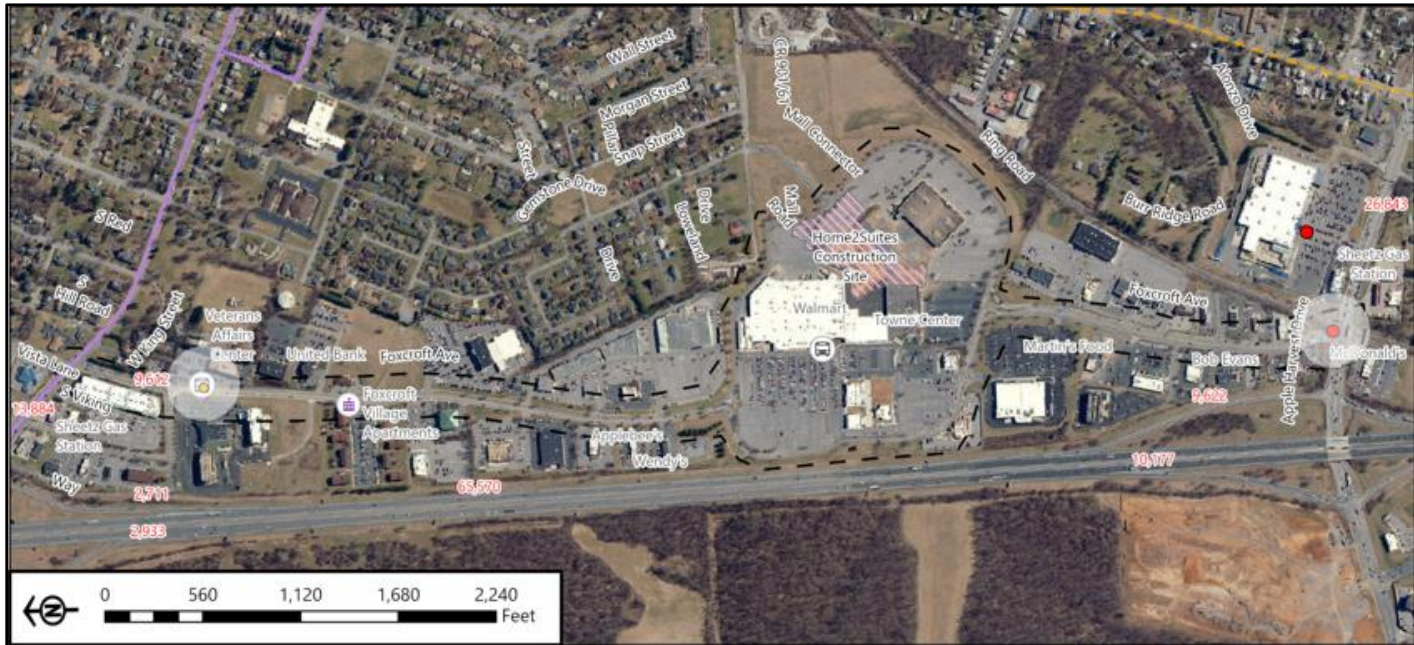
Figure 2. Aerial photo of pedestrian crashes on the corridor. One occurred in the northern Foxcroft Avenue section at Viking Way, the other at the intersection with Apple Harvest Drive.

WVDOT provided detailed crash data for crashes that occurred between 2010 and 2018. There were two (2) reported crashes involving a pedestrian over the data period, they are detailed in the table below. The 2011 crash involved a pedestrian trying to cross Foxcroft Avenue who was hit by a vehicle turning right onto Foxcroft Avenue from Apple Harvest Drive. The vehicle had a green light, which means the pedestrian was crossing the road with traffic but without a pedestrian signal phase (there are no pedestrian facilities at this intersection). Both crashes occurred in dark conditions, which contributed to the drivers not seeing the pedestrians in the roadway. A third pedestrian crash occurred in fall 2019,

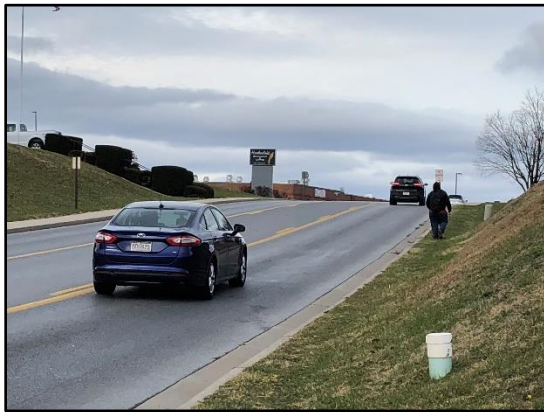
Left: Gaps in the sidewalk network leave pedestrians walking in the grass on the side of the road. Even in locations where sidewalk is present on the other side of the road, a lack of formal crossings often prevents pedestrians from crossing to use it.

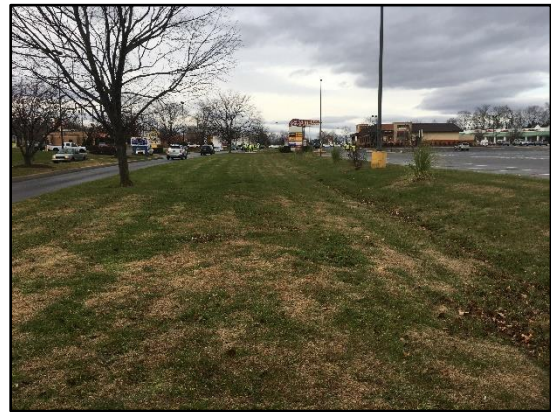
Right: This segment of Foxcroft Ave generally has a wide Right of Way which provides space for improvements.

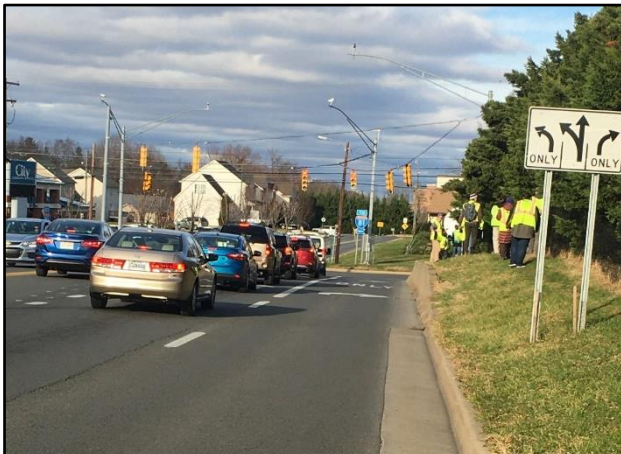
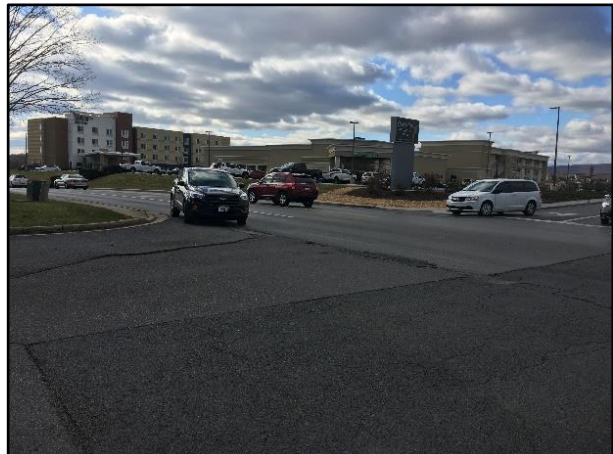
Left: Facing north on Foxcroft Avenue towards King Street, showing that there is no sidewalk on the east side of the street and a slope up a retaining wall. There are no crosswalks or pedestrian signal heads at the intersection. Right: The intersection of Foxcroft and Viking Way, showing that the intersection is wide and at the top of a hill. The sidewalk on the east side ends at the EPTA Route 10 Workforce Development stop, but there is no marked crossing that allows pedestrians to cross the street and walk on the sidewalk on the west side of the road.

- Coordinate with WVDOT to add LED lighting to the intersection with King Street.
- Discuss adding a sidewalk connection along King Street from Foxcroft Avenue to Downtown with property owners.

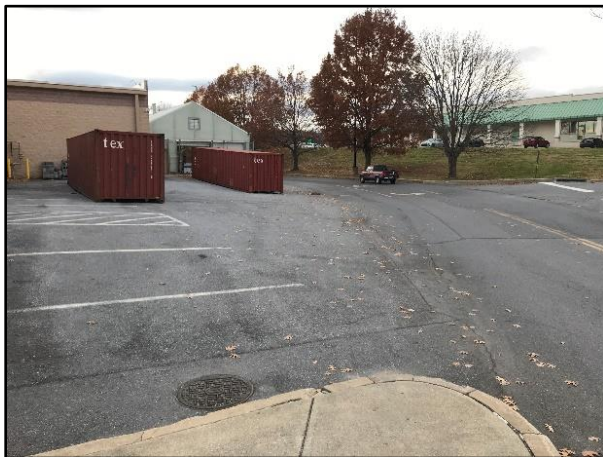
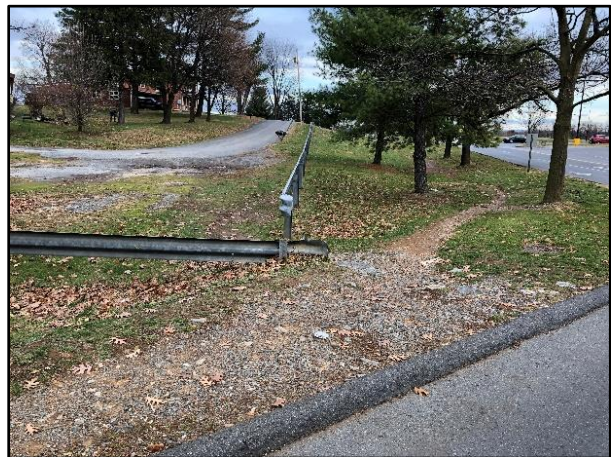
Left: A sidewalk missing a curb ramp behind the Walmart. The placement of containers and building make it difficult for drivers to see beyond the corner where pedestrians may be crossing to get to the stores on the hill.
Right: A strong desire line from residential areas north and east of Towne Center towards the Walmart. The lines make it clear that pedestrians frequently cut through the gap in the guardrail or walk on the path outside the guardrail; pedestrians were observed here during the field review.

- **Visibility:** There is poor visibility around the Walmart Garden Center due to the shape of the building and containers in the loading zone that further shorten drivers' sight distance and require pedestrians to step out into the road to see vehicles.

- Consider a midblock crossing across the ring road near the desire line behind Walmart (in the photo above) to connect pedestrians to the existing sidewalk. The crossing should include ADA compliant curb ramps and connecting sidewalk or an improved path, so it may involve a more involved study of the crossing.

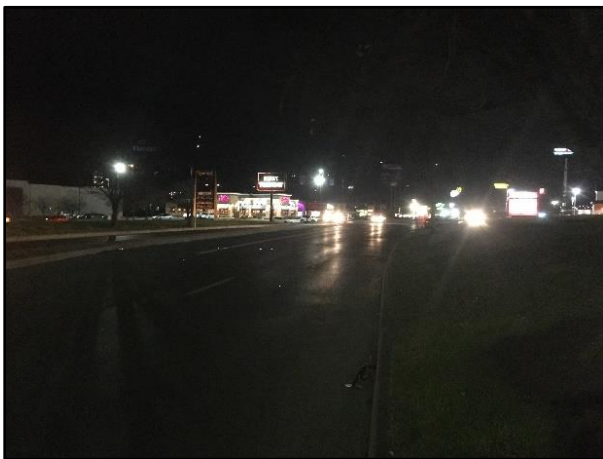
Left: The southern end of the corridor is dark without functional lighting.

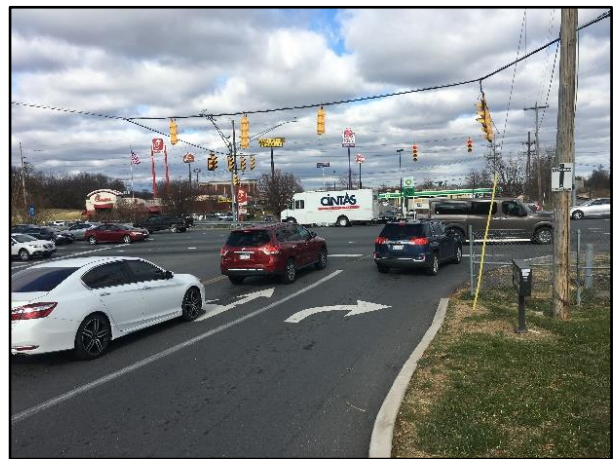
Right: The intersection of Foxcroft Ave and Apple Harvest Drive; it is a busy intersection with many turning movements, and there is no pedestrian signal phase or crosswalks.

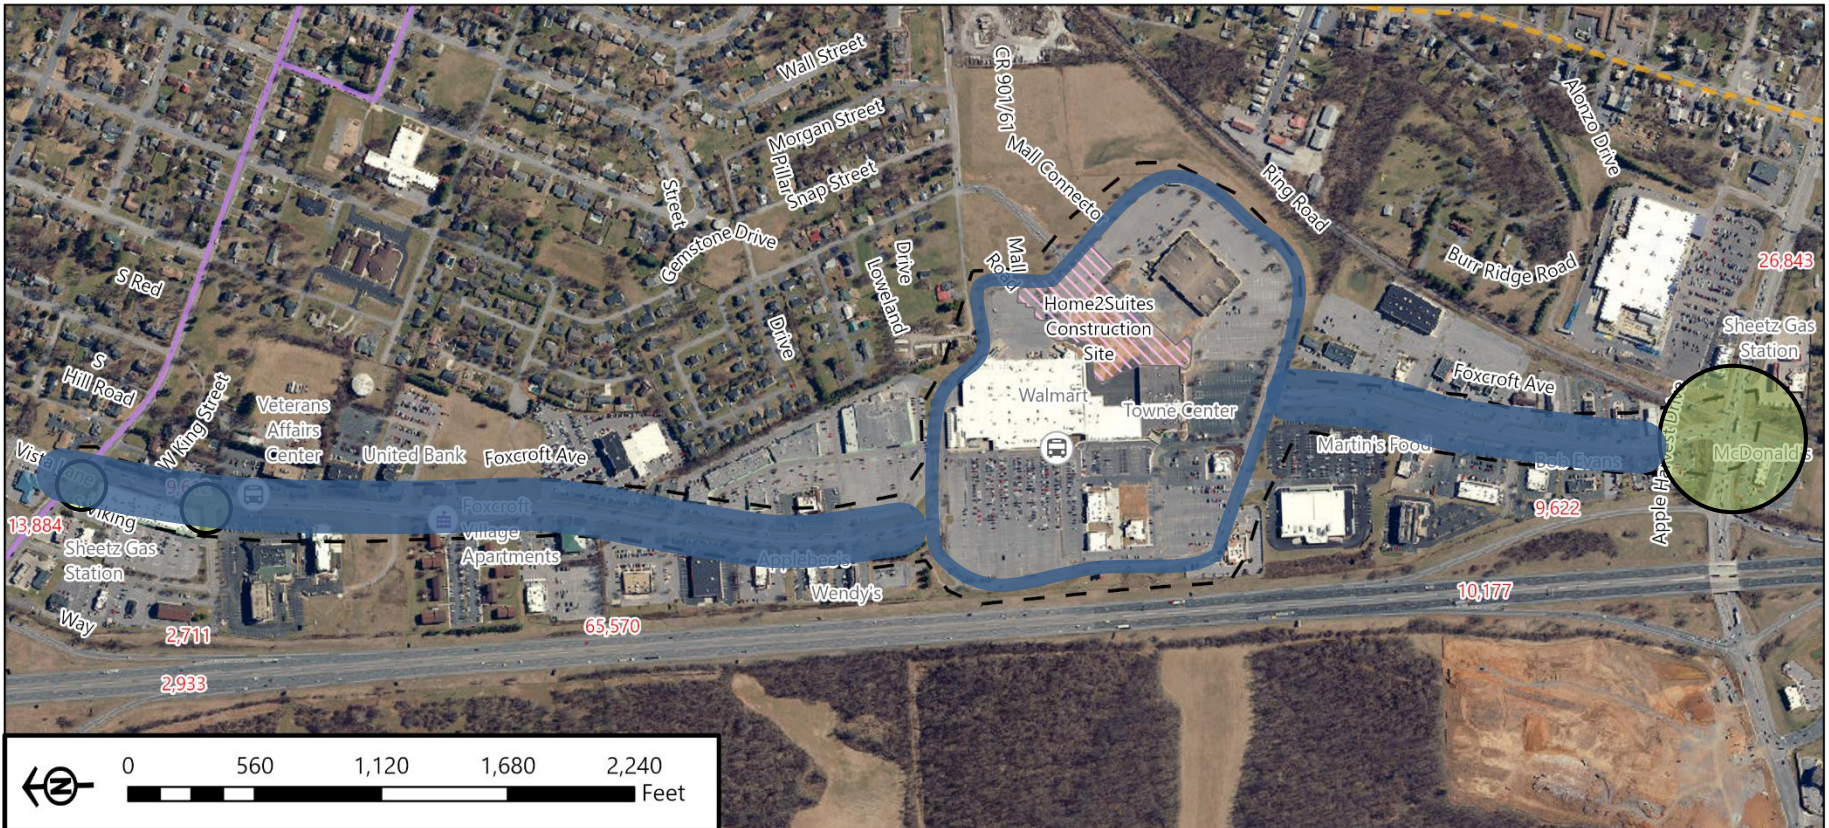
All Crashes Along Corridor (2014-2018)

- Most crashes along Foxcroft Ave w/o intersecting street (57)
- Apple Harvest Drive Intersection (26)
- Other locations
 - Mall Loop Road (5), Viking Way (2), King Street (2)

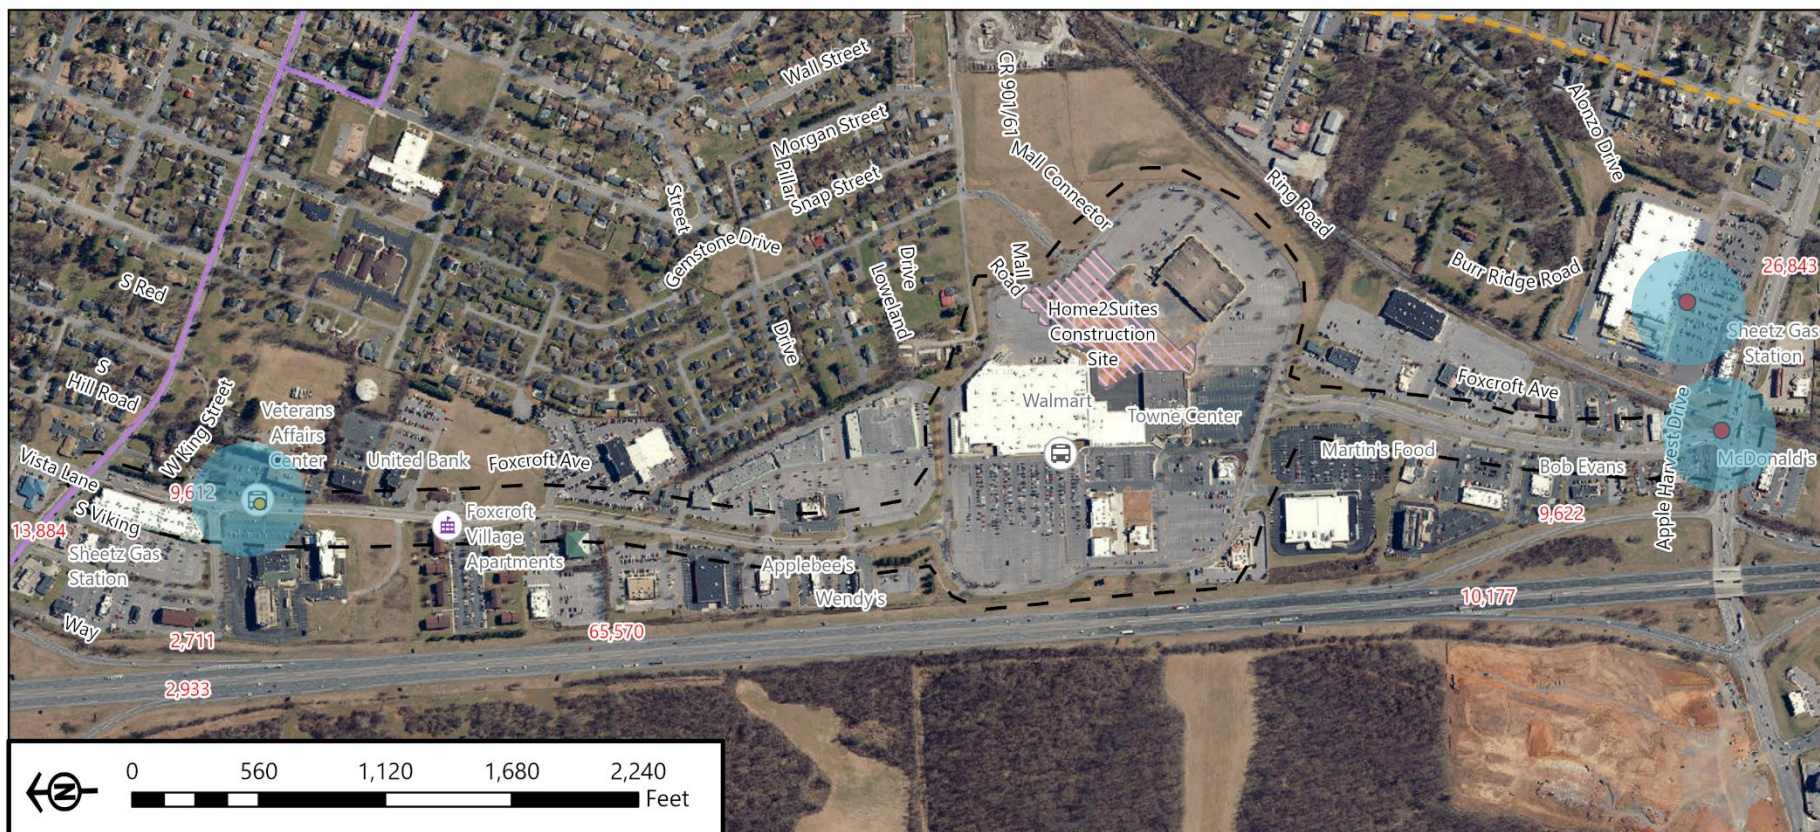
Pedestrian Crashes (2010-2019)

- Two reported crashes along corridor: K & B
- Crossing roadway (not yielding), run out into road
- Both crashes after 6PM (low light conditions)
- Third crash (K) in parking lot (outside corridor)

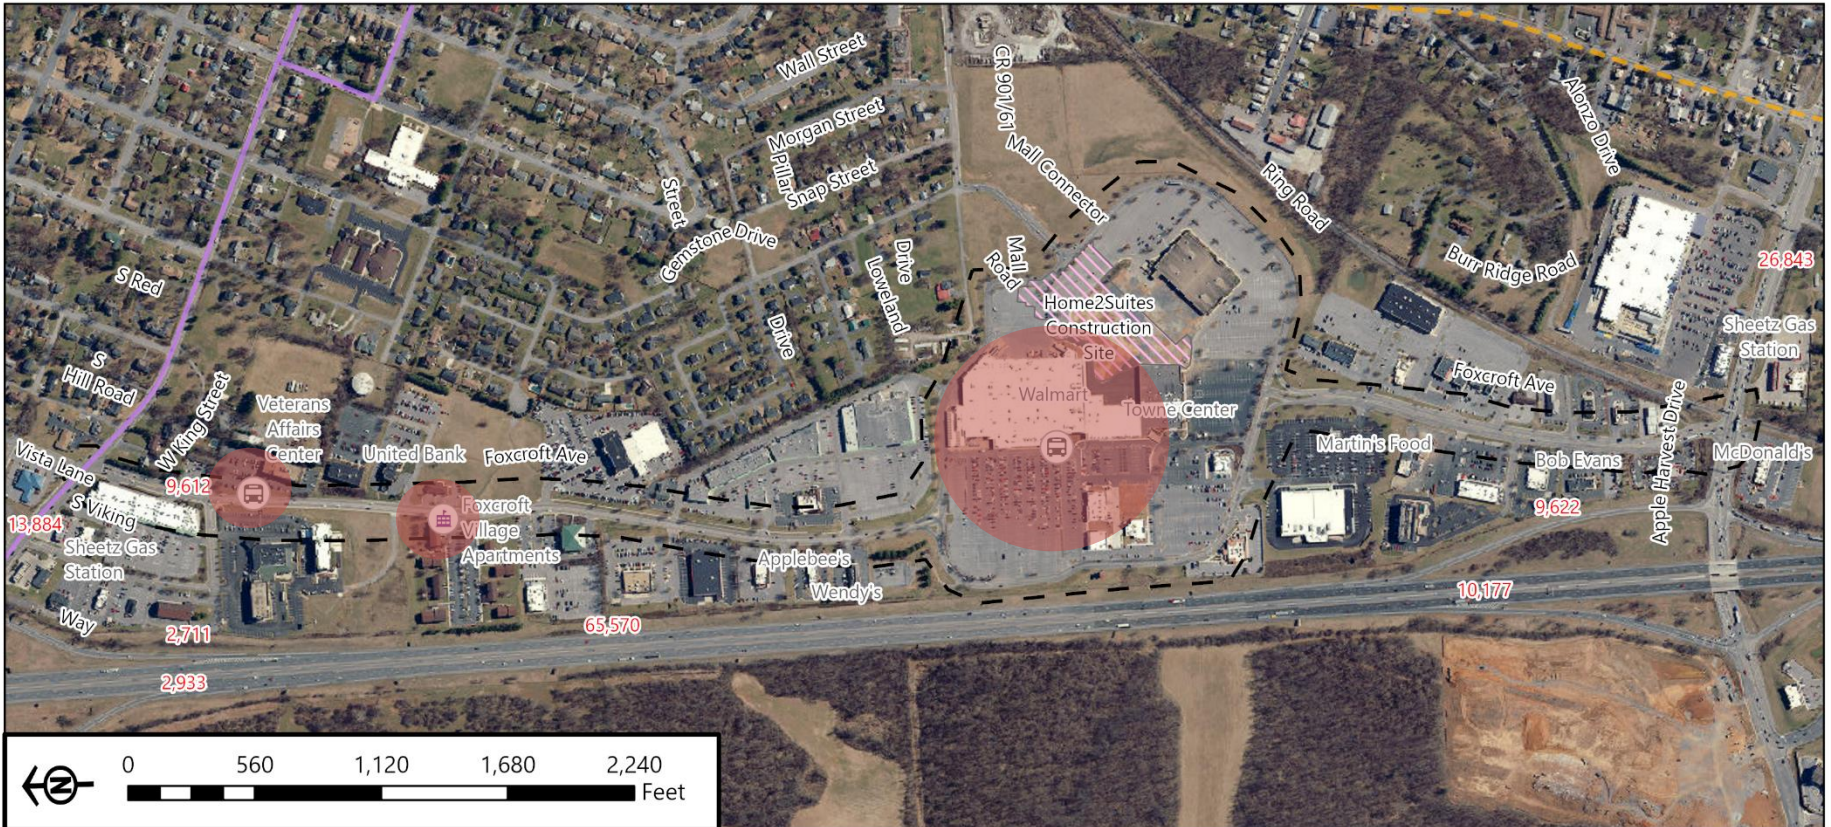
Transit Stops – Avg Daily Activity

- Two EPTA stops along corridor
 - Workforce Development B/As: ~6 weekday, ~1 weekend
 - Walmart B/As: ~75 weekday, 14 weekend
- School Bus Stop
 - Foxcroft Village Apartments: > 10 weekday

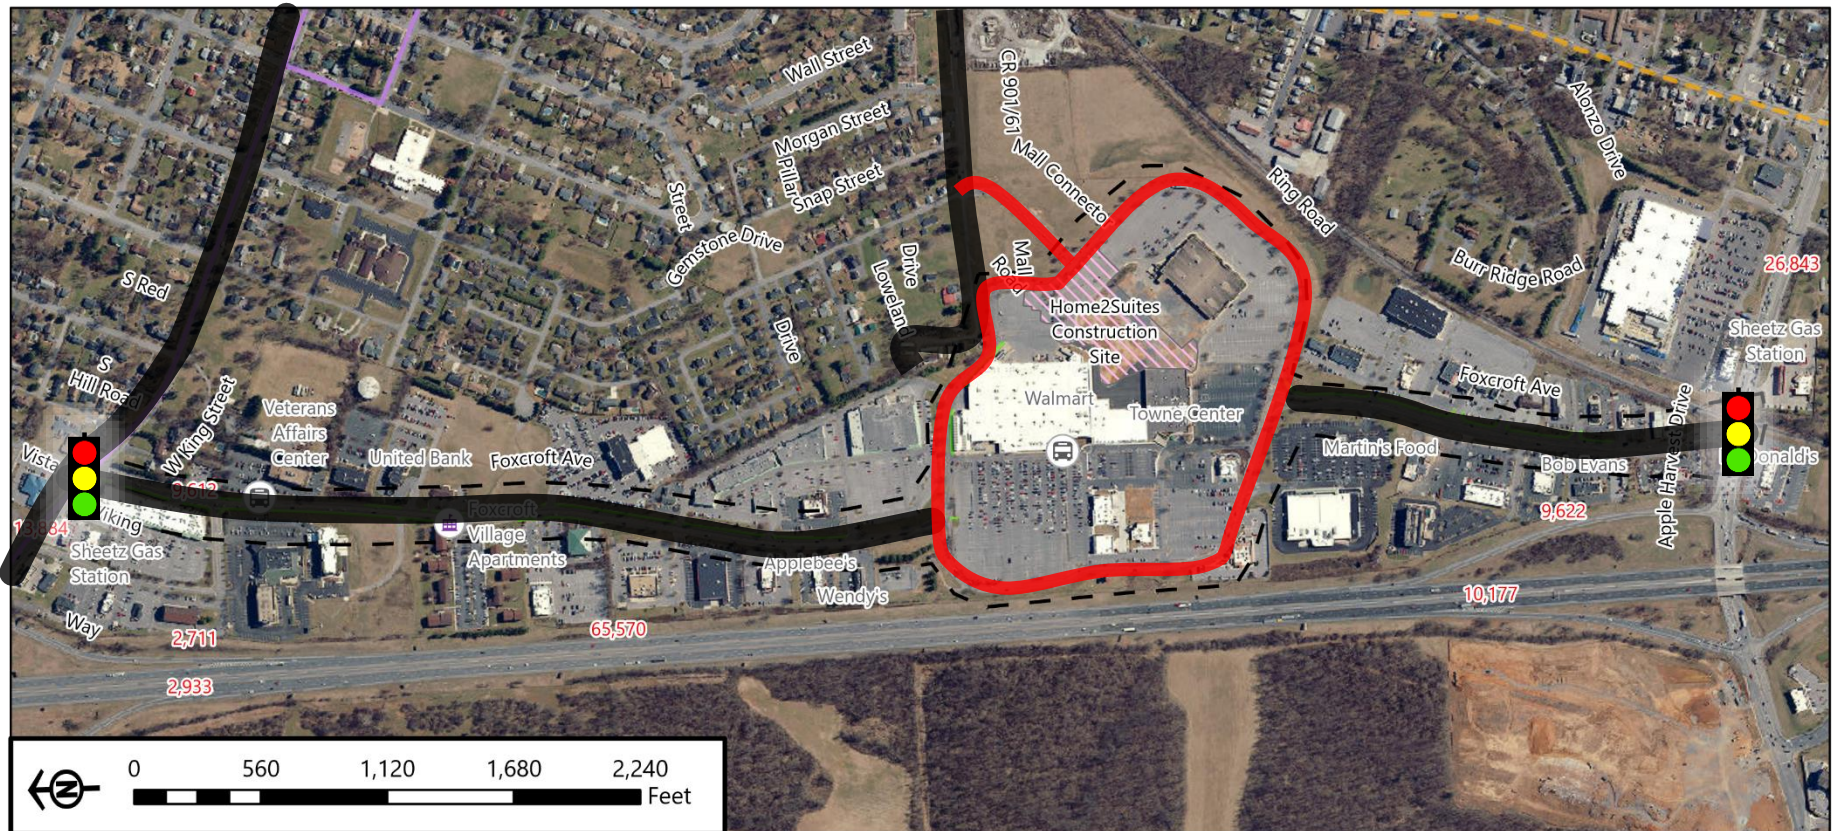
Other Corridor Attributes

- **State vs. private** roads
- Signalized intersections
 - No pedestrian phase in signal plans
- Sidewalks along sections
- Other pedestrian facilities: crosswalks → confirm in field
