HAGERSTOWN

BICYCLE & PEDESTRIAN
PRIORITY AREA PLAN

PREPARED FOR:

May 2020

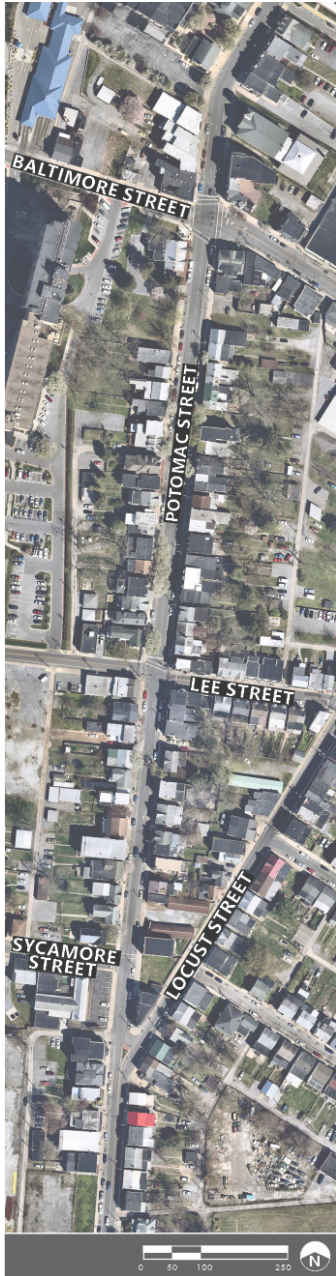
The reclaimed space, which represents 8 to 10 feet as shown in the cross-section image below, could also be used for a community arts project, stormwater management facilities, and/or dedicated corrals for resident's trash cans.

Potomac Street between Baltimore Street and Locust Street.

For pedestrians, the sidewalk could be formally widened, or the pedestrian area could be extended into the street through the use of planters, wheel stops or flex posts as lateral buffers. If flex posts are preferred, an on-street parking demand survey is recommended. No parking occupancy data is available at the time of this report, but if the parking is generally well-utilized, bollards will likely provide enough of a barrier between pedestrians and motor vehicles traveling along Potomac Street. If the parking is not well-utilized, pedestrians may feel exposed or unsafe without a more formal barrier between them and moving traffic.

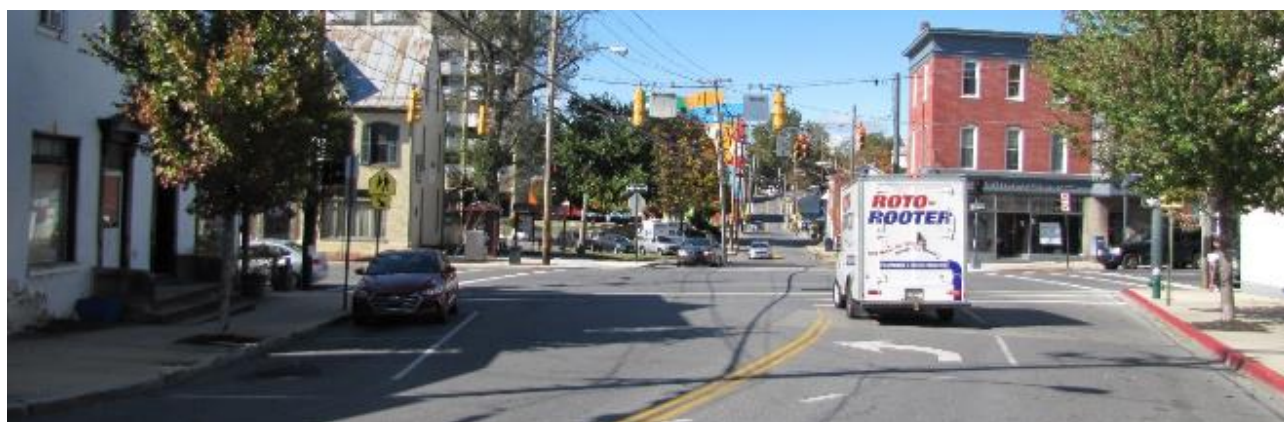
As depicted in the aerial and photo below, the westbound approach along Baltimore Street is far wider than the receiving lanes west of the intersection. This results in skewed crosswalk design and a long pedestrian crossing along the east crosswalk leg. Not only are there pedestrian challenges to this intersection design but it also is an unconventional experience for drivers - vehicles traveling westbound through the intersection must track left in order to end up on the receiving lane west of the intersection.

Super wide two-way two-lane Baltimore Street intersects with Potomac Street.

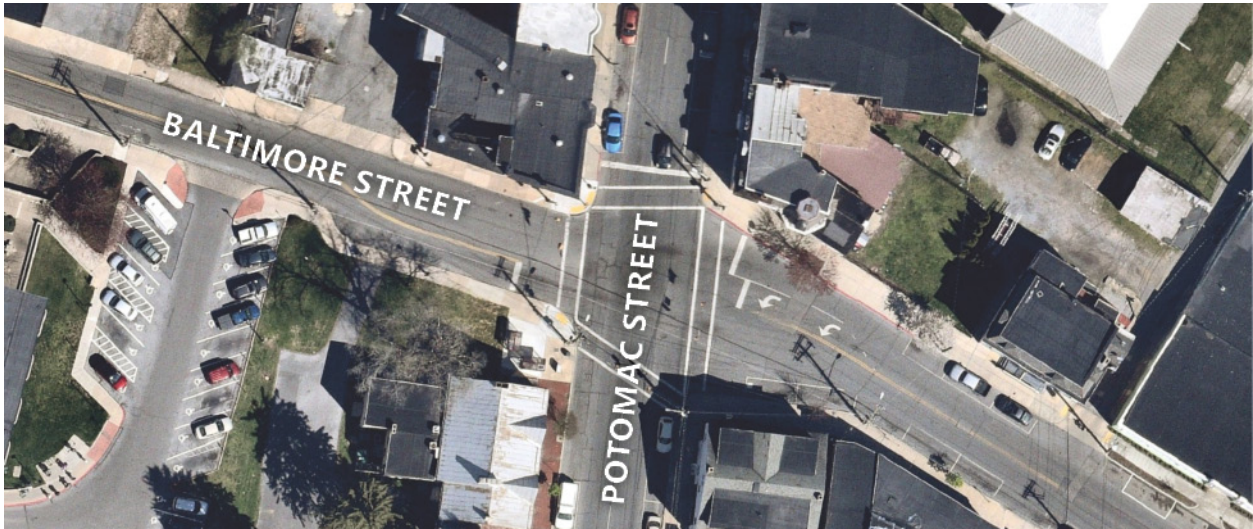
Satellite image shows Potomac Street at Baltimore Street intersection.

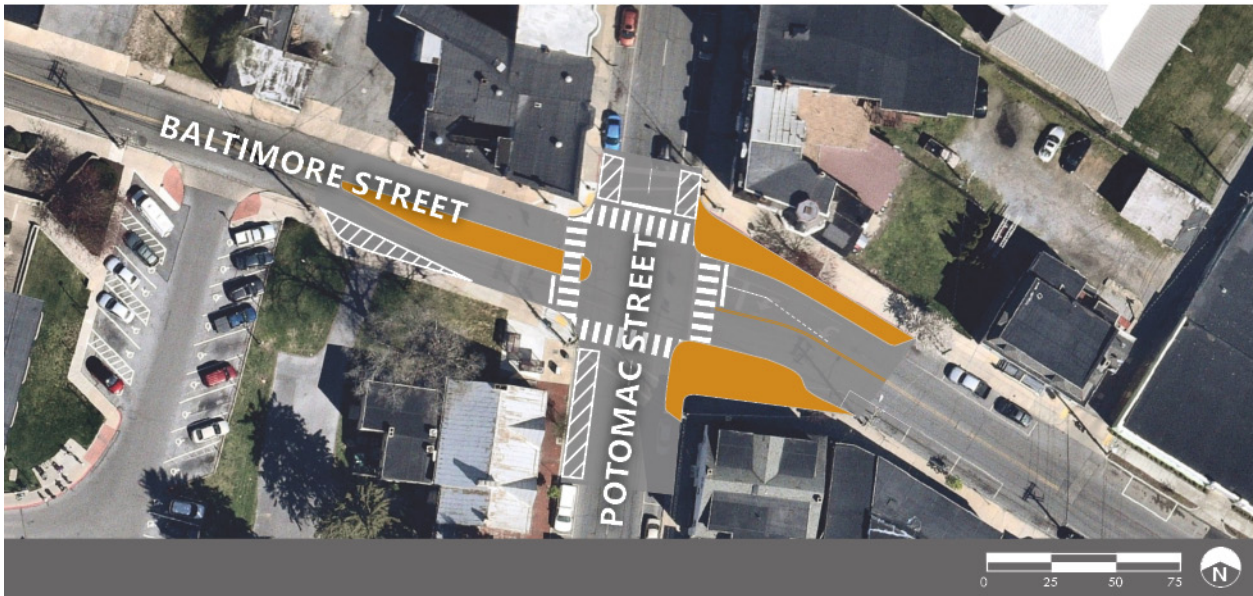
To improve the intersection, it is recommended that both the northeast and southeast corner curbs be modified, either through soft-scaping (flex posts, striping and the like) or hardscaping (raised curbs and the like). In response to the updated curbs, the crosswalks would be realigned. This adjustment would maintain sufficient right-of-way for both the existing westbound left-turn and through lanes, but it would improve safety and comfort for travelers through the intersection. The sketch concept below depicts roughly what the new intersection design could look like.

Extending the curb and reducing the crossing distance will improve pedestrian safety and visibility.

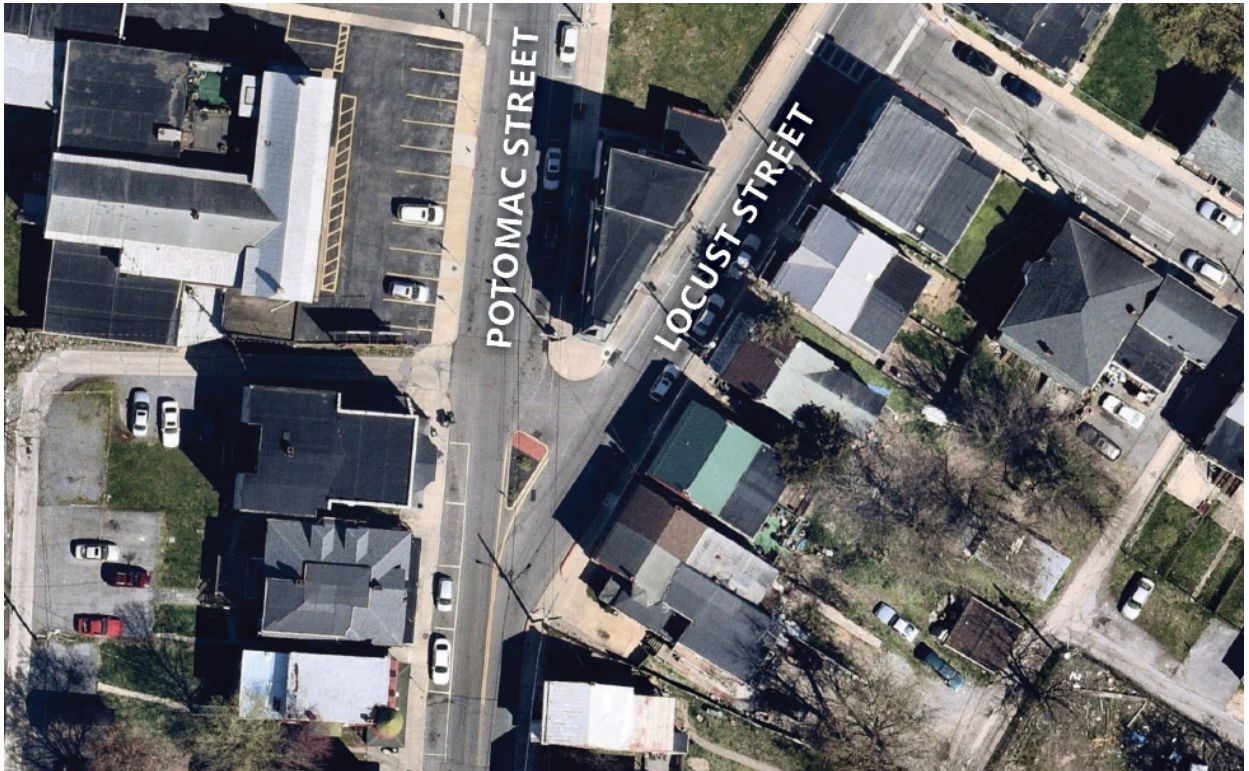
Satellite image shows Potomac Street and Locust Street

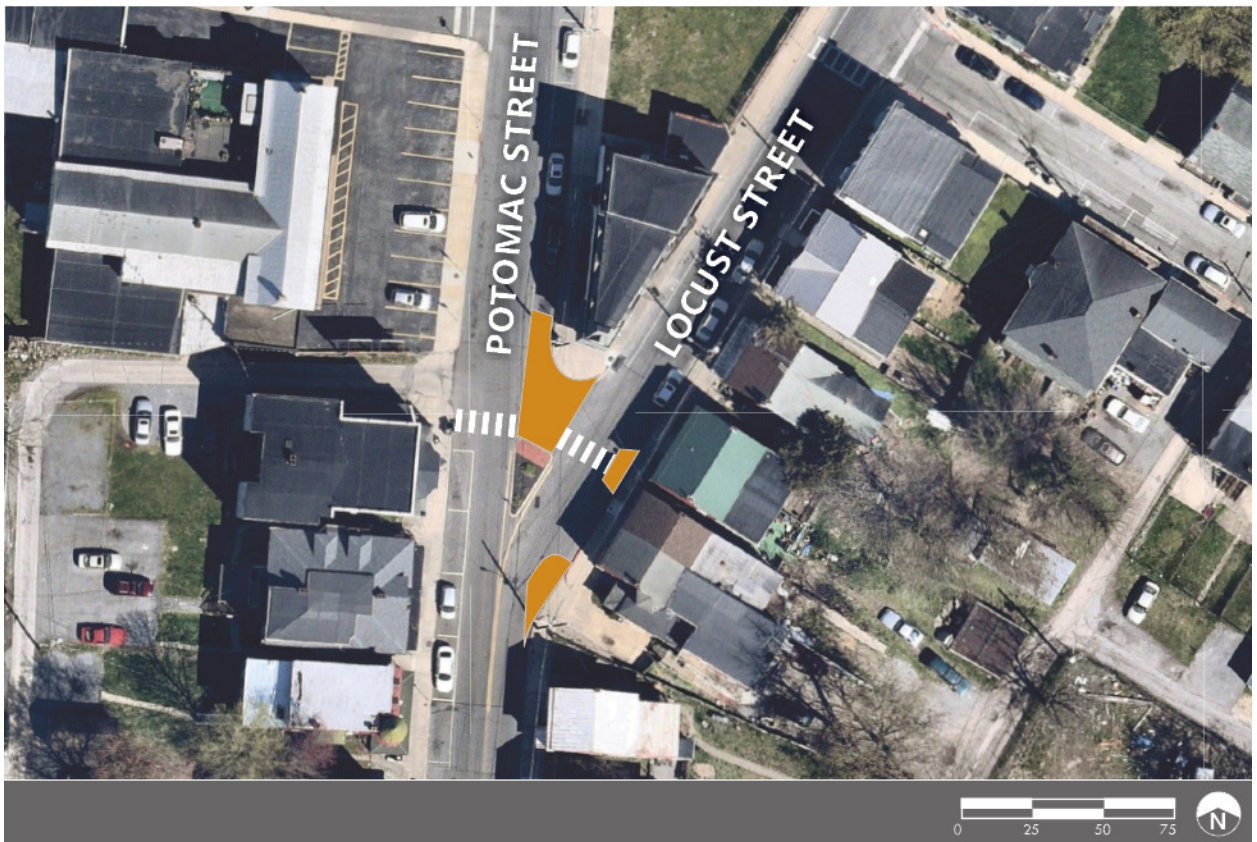
- **Closed Cut-Through with High Visibility Crosswalks:** By closing the cut-through to vehicle traffic, Hagerstown can create a small community meeting space in front of Locust Point Market. This space could be filled with chairs or picnic tables for residents or market patrons. In addition, high-visibility crosswalks are recommended across both Potomac Street and Locust Street, providing a direct crossing across the two roadways. The high-level concept included below provides an example of what revised intersection alignment could look like; a 2-stage crosswalk allowing pedestrians to cross a single lane of traffic.

Closing the cut-through could improve pedestrian safety.

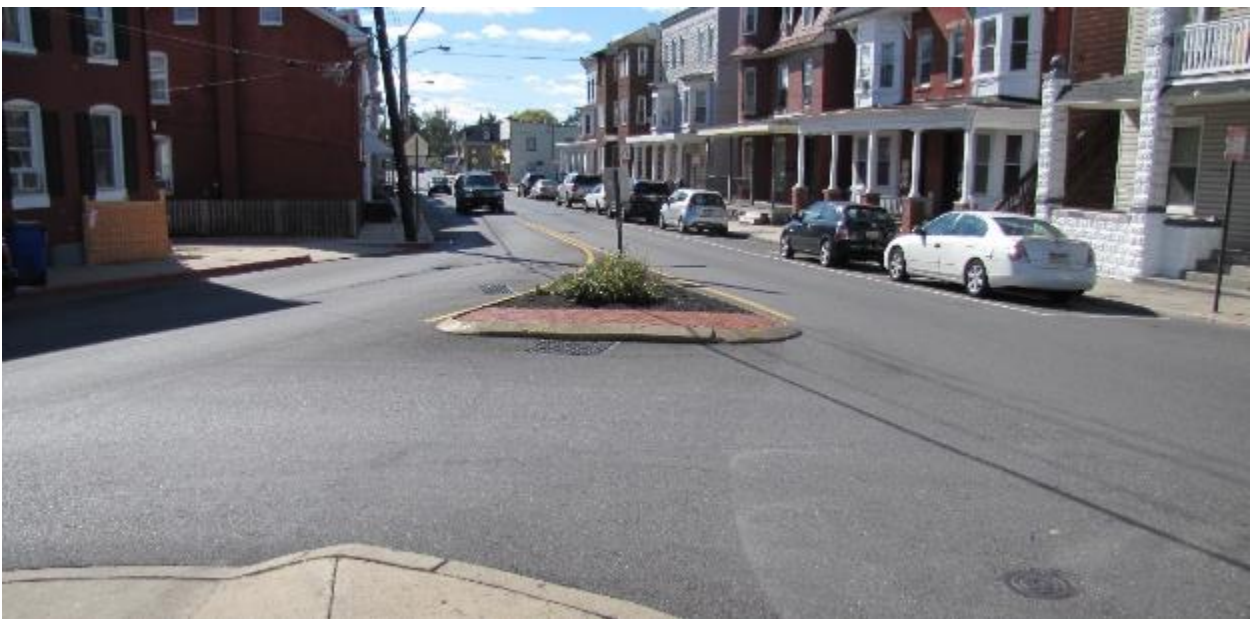
Lack of crossing marking or signage at Potomac Street and Locust Street can be a potential safety risk.

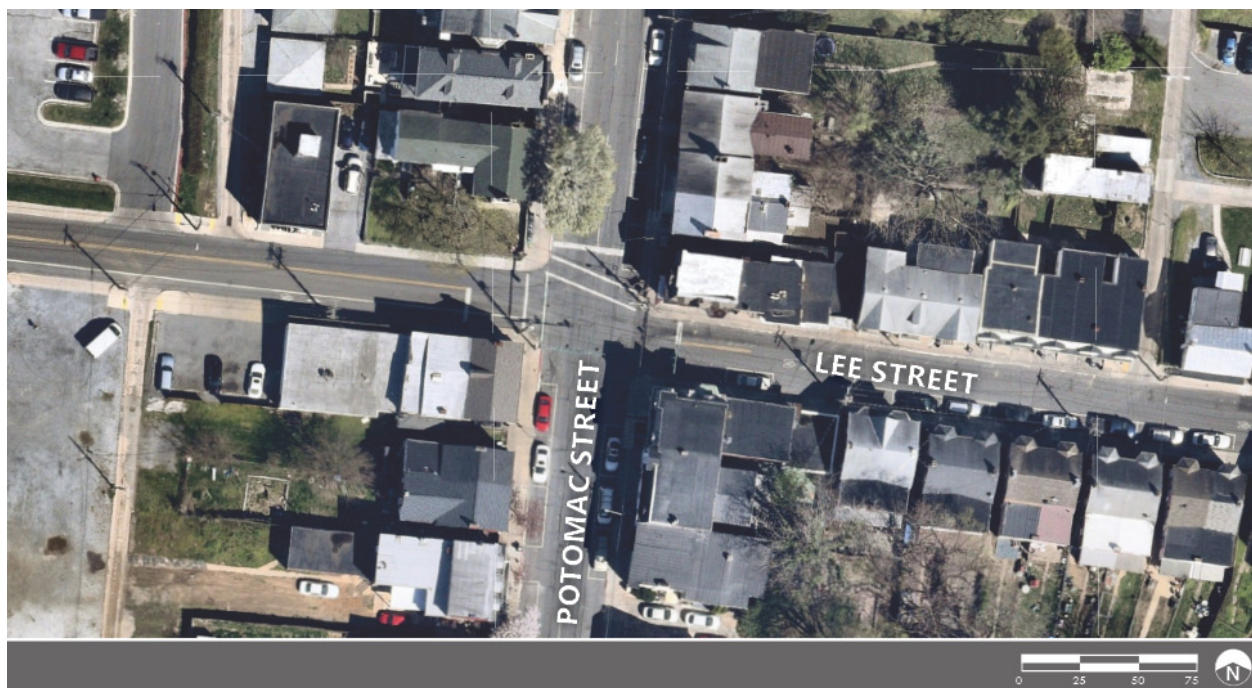
Satellite image shows Lee Street and Potomac Street showing incomplete crossing at the intersection.

The curb extension should be designed conscious of the right-of-way and drainage constraints, and it could be designed as stormwater management infrastructure for dual benefits of safety and environmental sustainability.

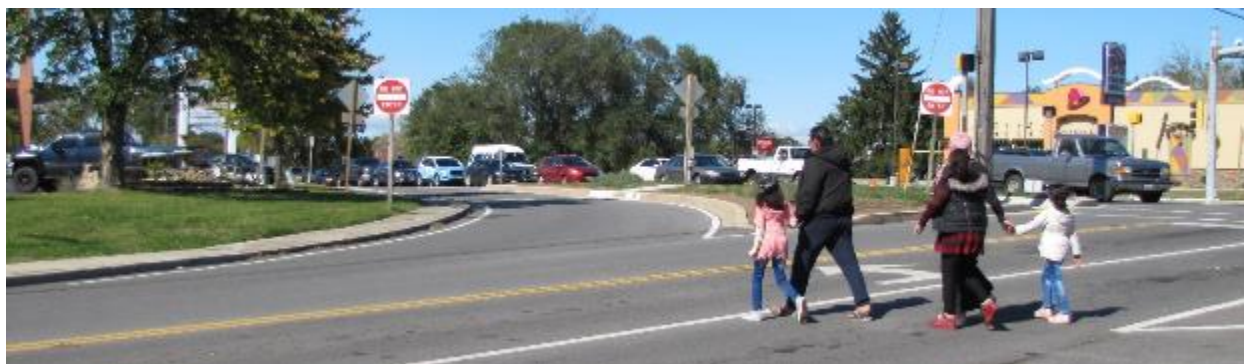
Even since the recent installation of crosswalks, unsafe crossings have been observed. Pedestrians generally want to take the shortest route possible and do not always use the designated crosswalk. Given the intersection configuration, pedestrians crossing Cleveland Avenue must cross three crosswalks: Cleveland Avenue itself as well as two channelized right-turn lanes (there are channelized right-turn islands at all intersection approaches). Removing the eastbound channelized right-turn has been discussed but has not been prioritized for implementation.

Pedestrians jaywalk across Cleveland Avenue rather than utilize the new crosswalks.

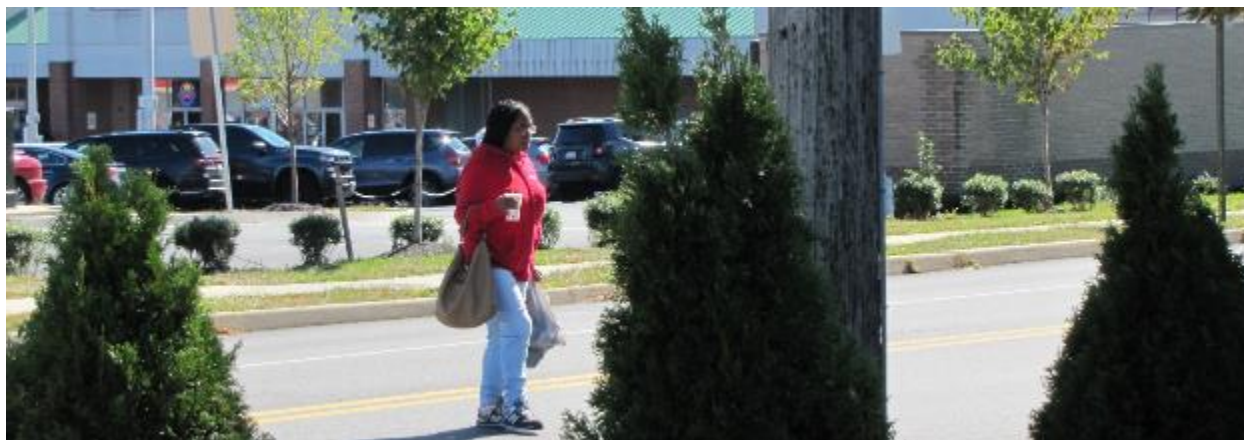
Unsafe mid-block crossing occurs with at Cleveland Avenue near Dual Highway.

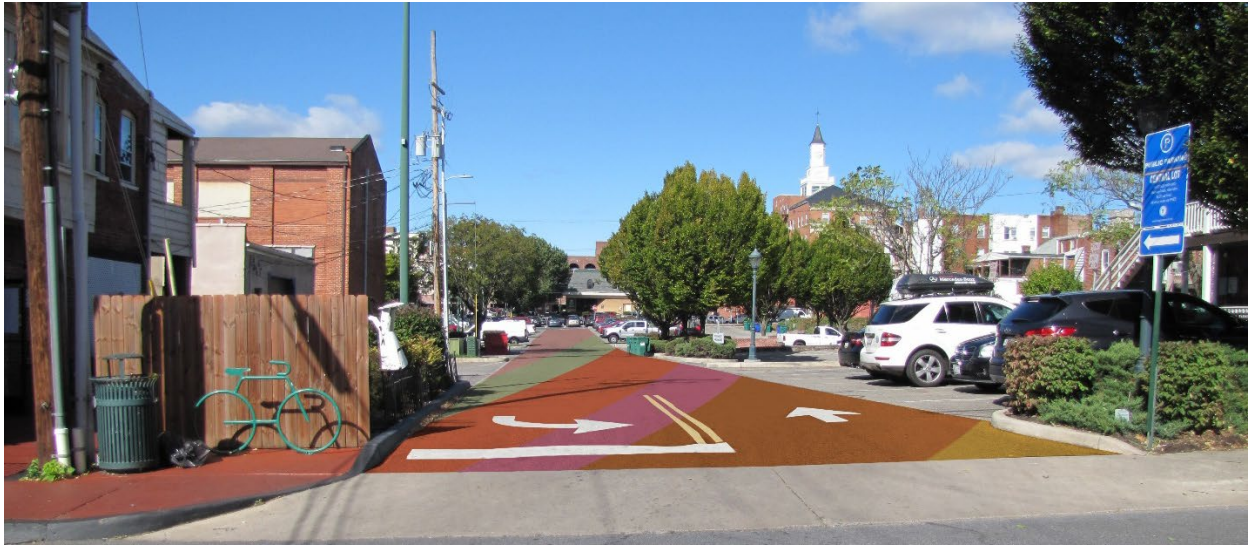
Use pavement colorization or pavers (opportunity to reduce impervious surface of the alley) to demarcate the bike and pedestrian travel route

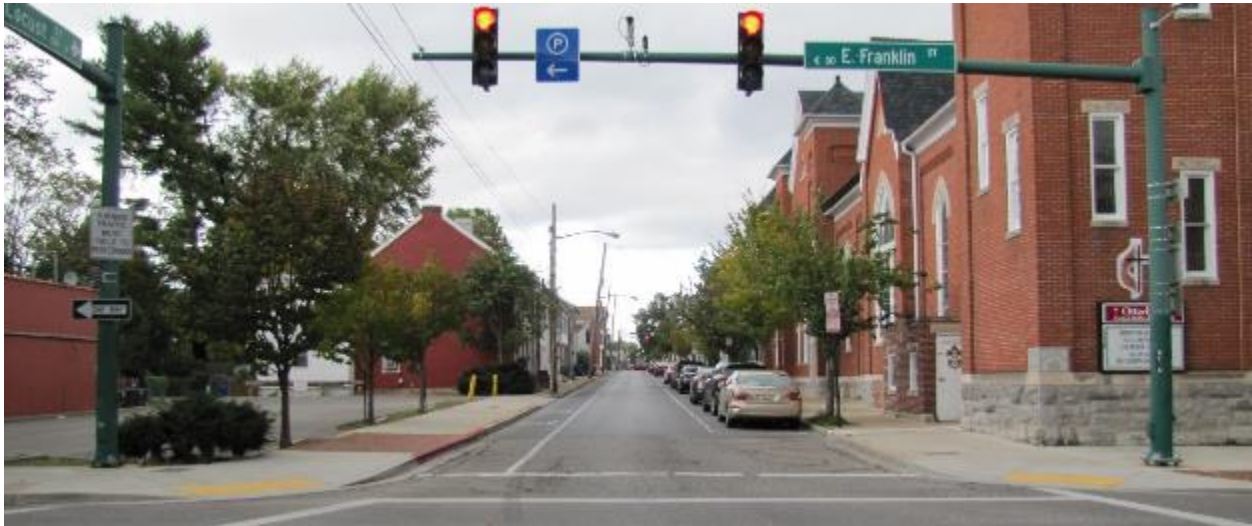
While there are marked crosswalks at the intersection of Franklin Street and Locust Street, there is no pedestrian signal indicating when pedestrians should cross.

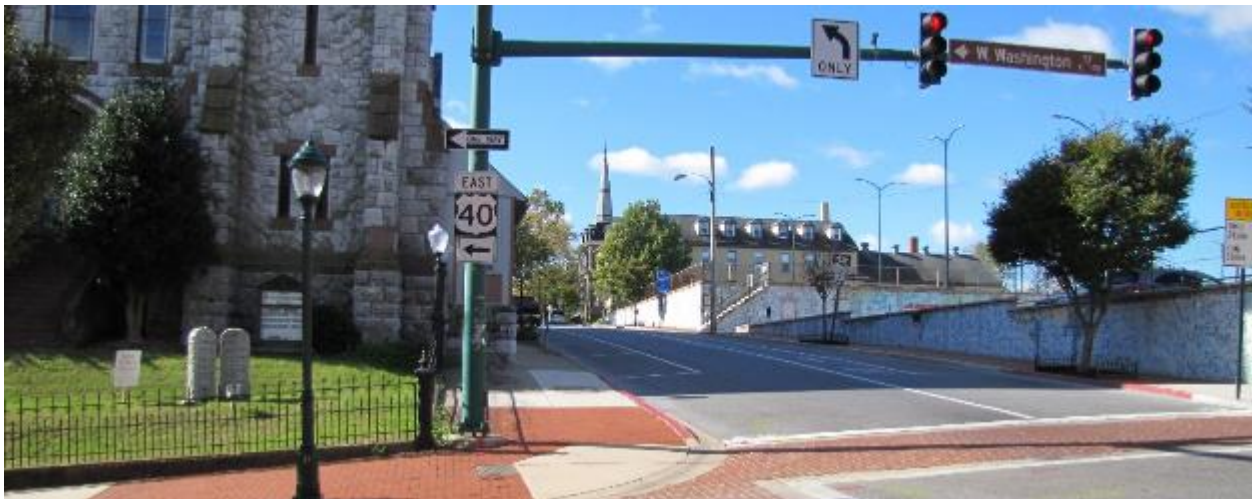
The intersection of Washington Street and Prospect Street includes a decorative crosswalk. Adding a pedestrian signal head would indicate to pedestrians when it is permitted to cross the street.

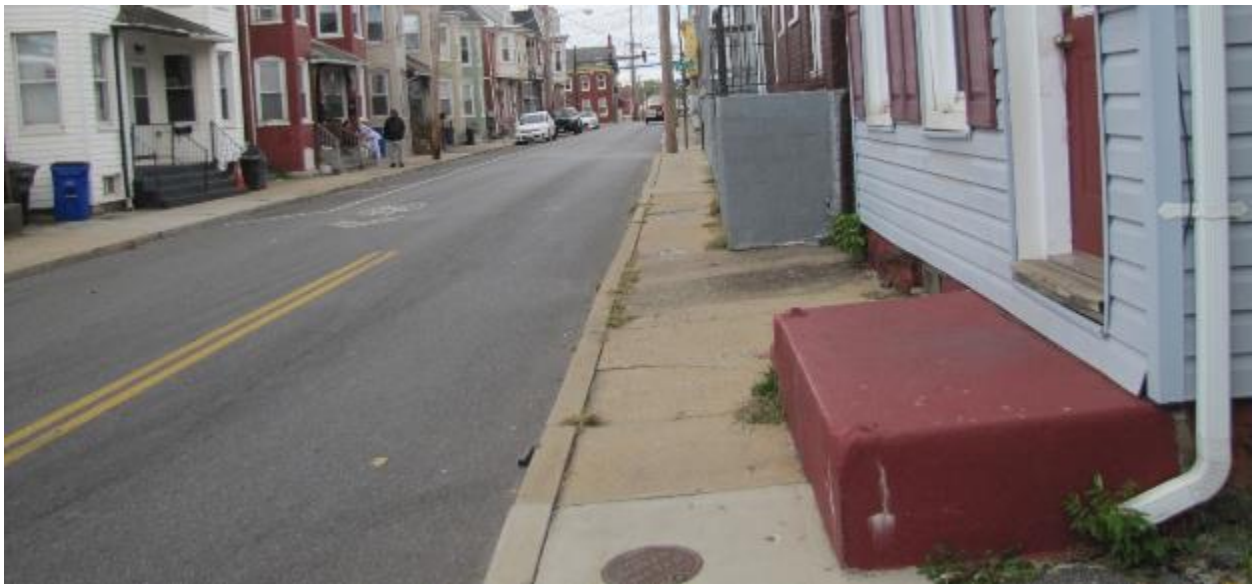
Residential stoops encroach on the sidewalk, narrowing space for pedestrians (Lee Street between Locust Street and Potomac Street).

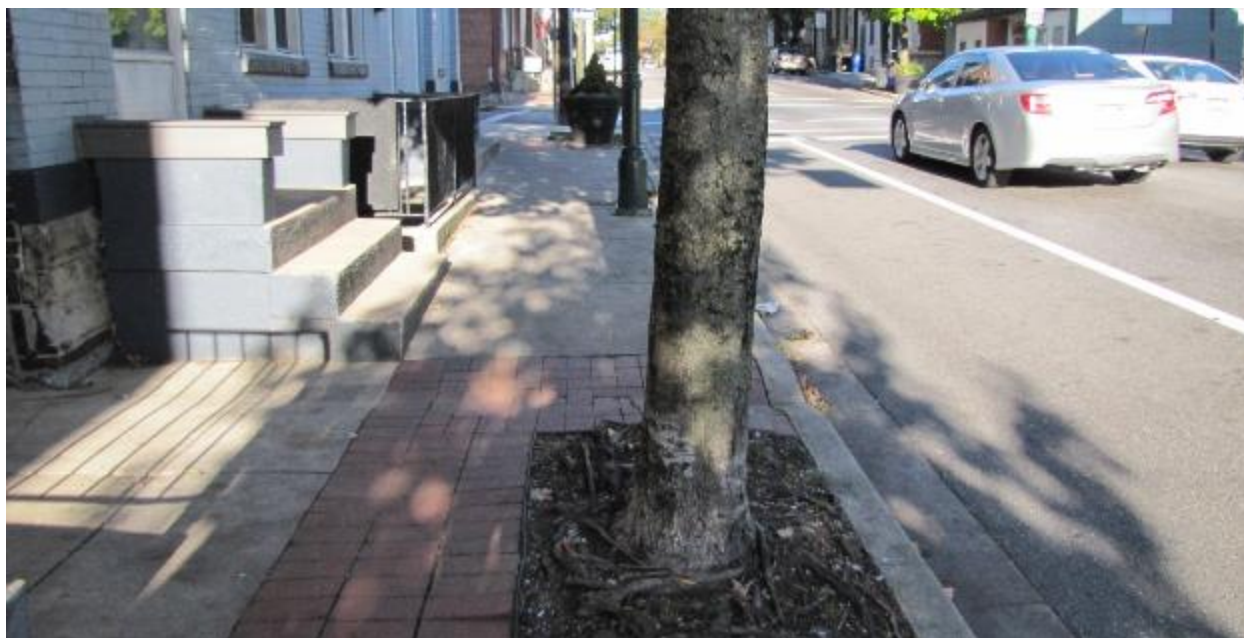
Signs, lamp posts, and trees narrow the throughway for pedestrians (Franklin Street between Mulberry Street and Cannon Avenue).

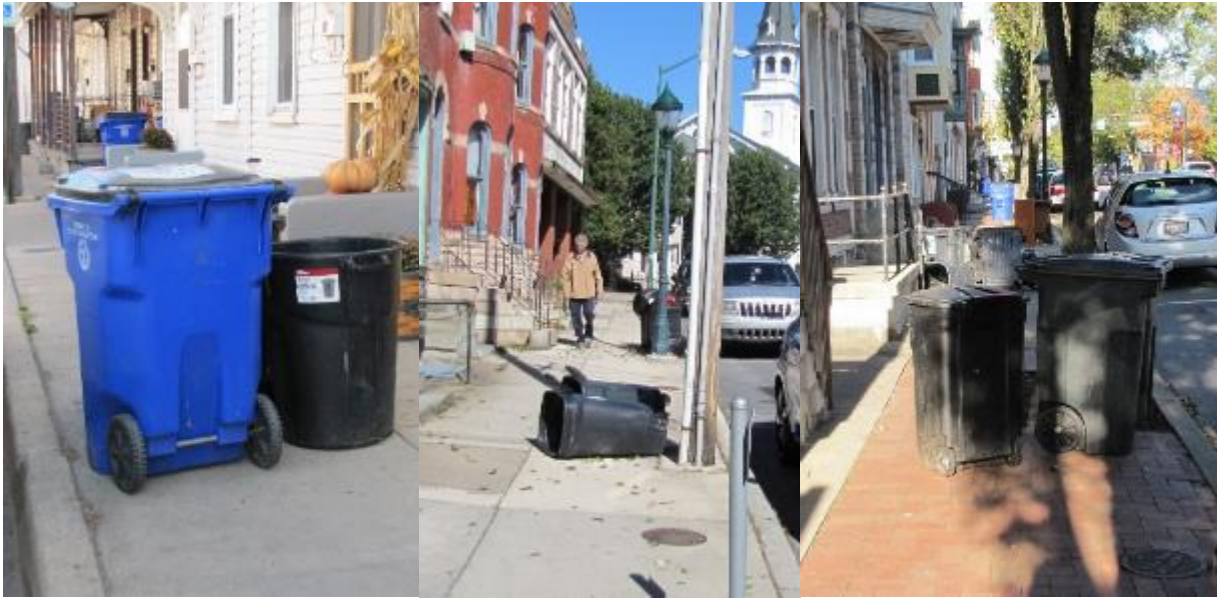
Trash cans block sidewalks on Locust Street (left), Potomac Street (middle), Franklin Street (right) limiting space for pedestrians.

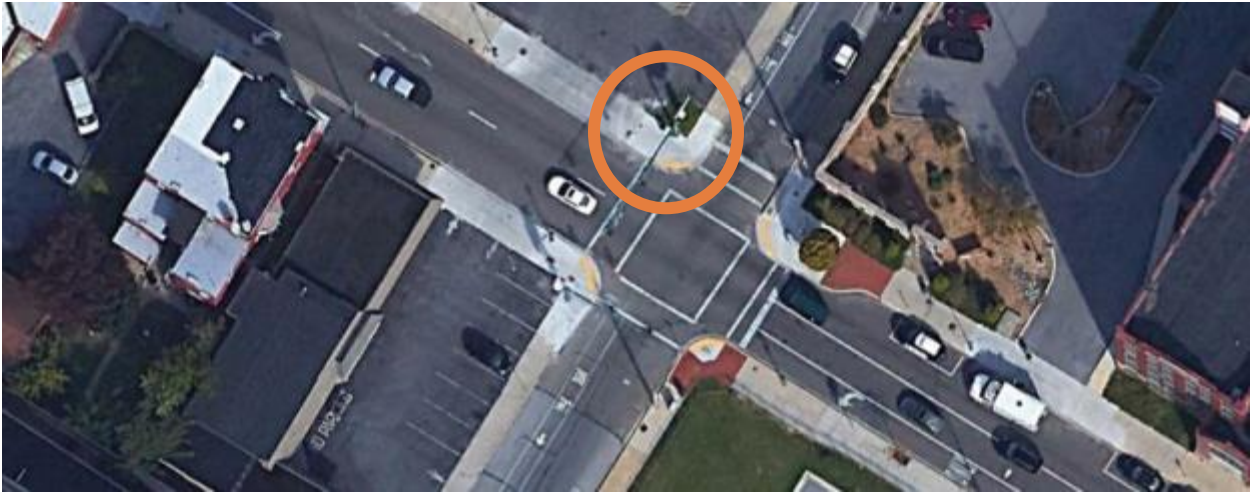
Candidate for bulb out on northwest corner of Prospect Street and Franklin Street.

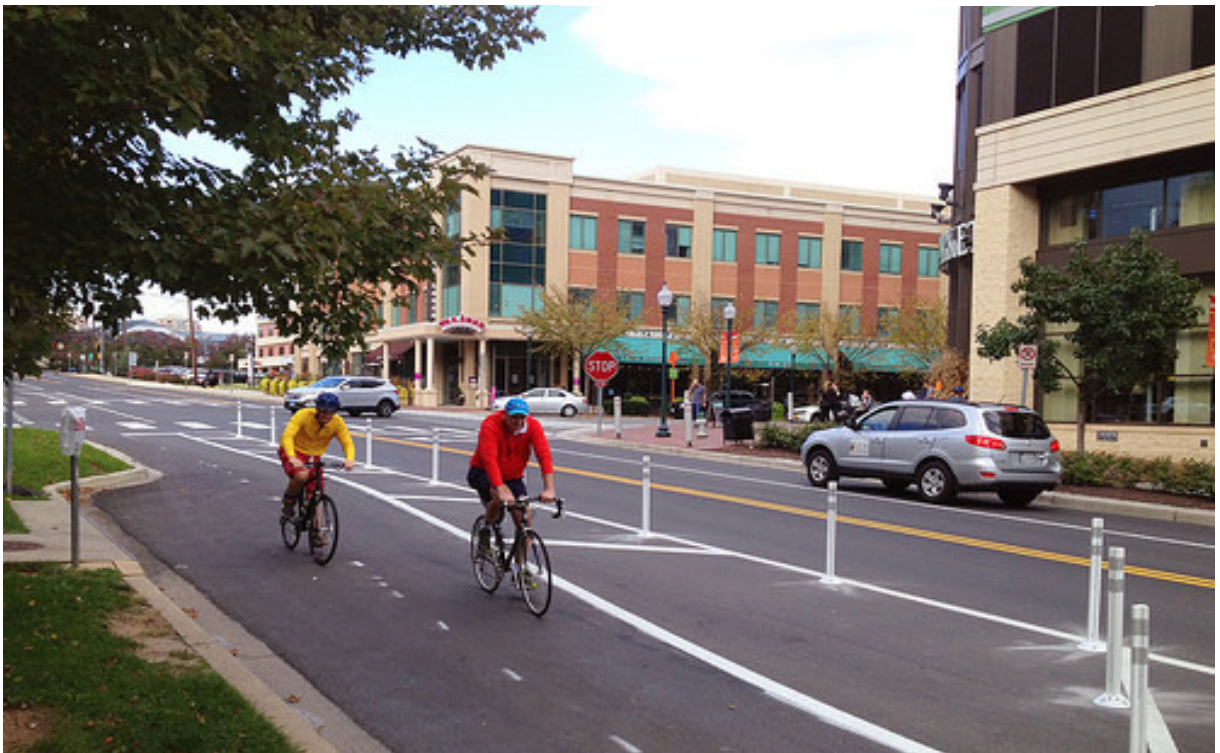
On-way protected cycle track on the left is separated using marking, flexible delineator post at Woodglen Drive cycle track (photo from GGW)

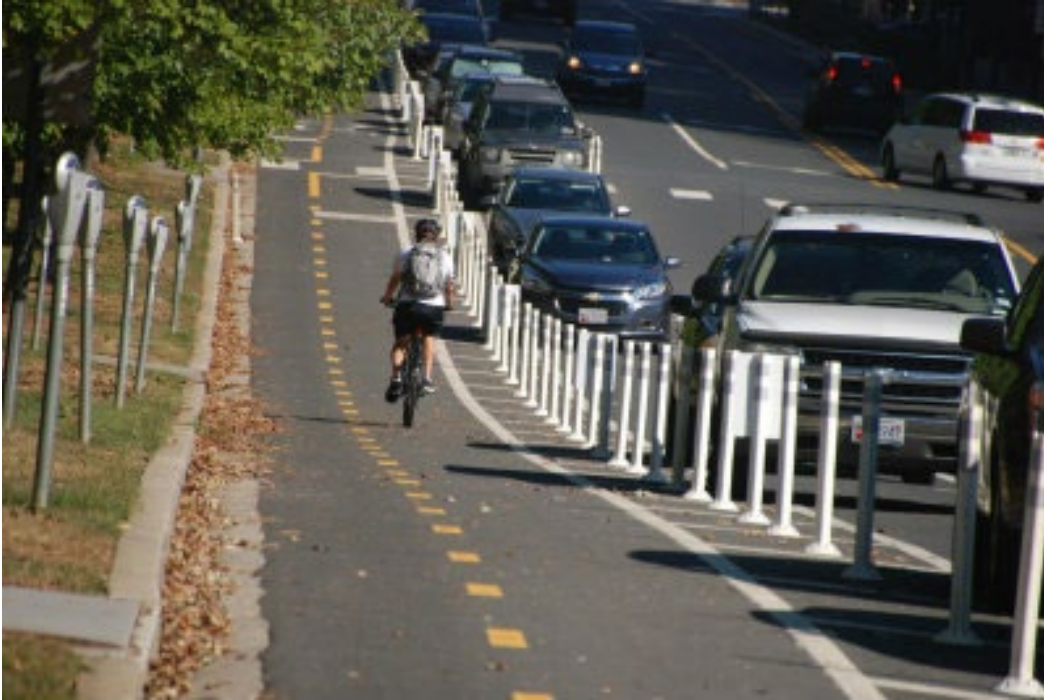
People are biking on buffered bike lanes where a wide marking separates them from the auto lane on Woodglan Drive, Rockville, MD (photo from MCDOT)

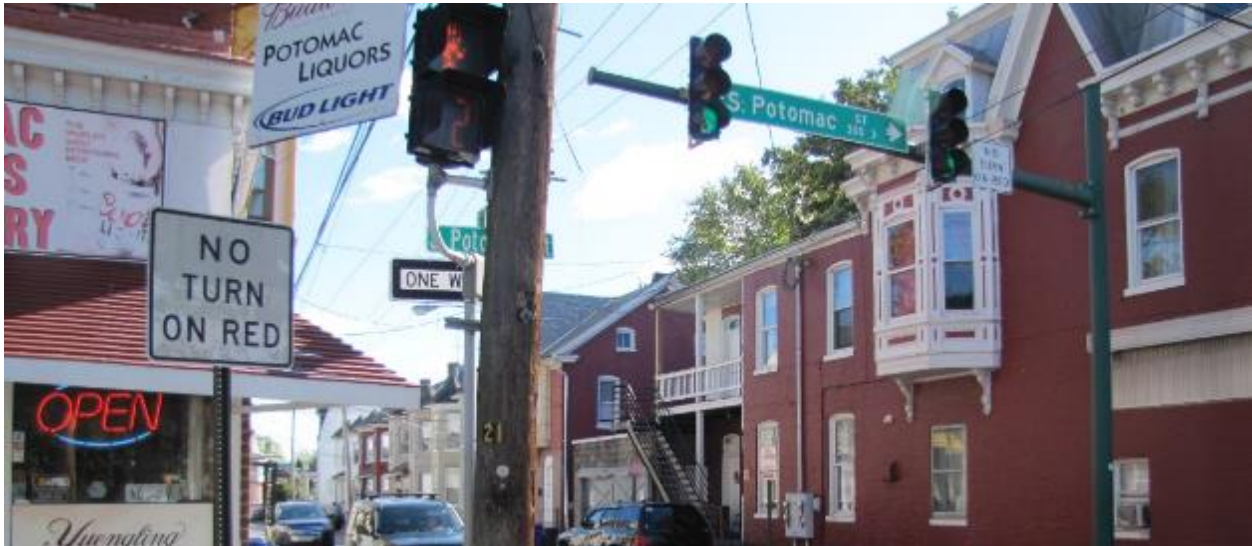
Pedestrian countdown signal at Potomac Street and Lee Street.

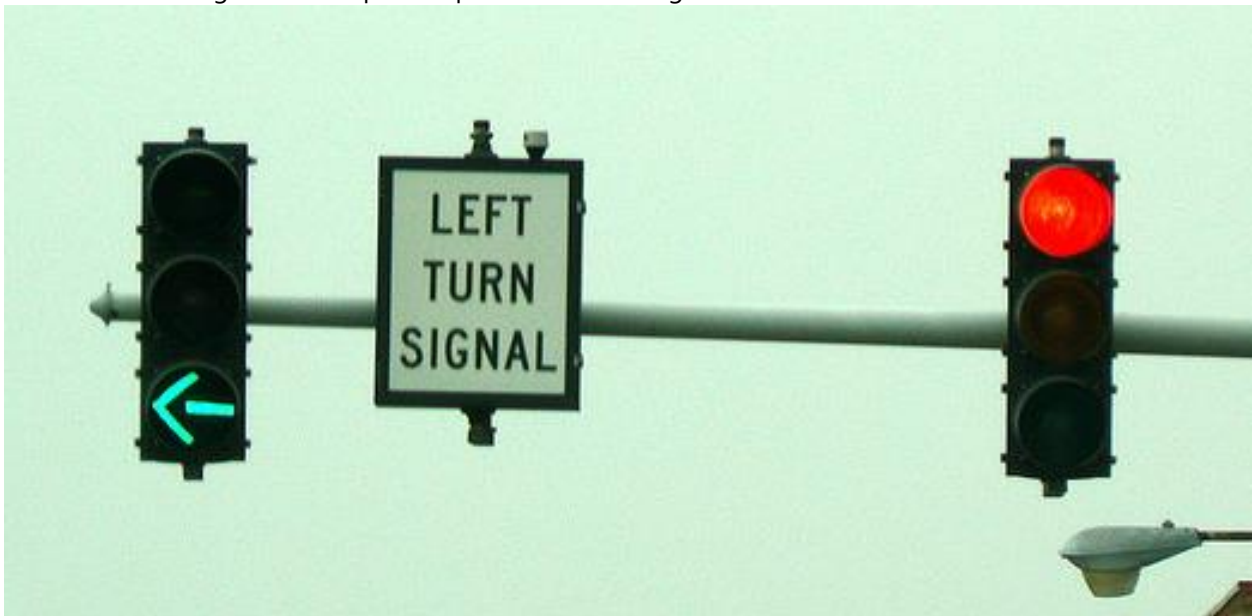
Protected left turn signal enforces protected left turns (Photo from Flickr - Benny Mazur)
