Road Safety Audit

Washington Street (US 40 Eastbound)

Burhans Boulevard to Cannon Avenue Hagerstown, Maryland Conducted on:

November 28, 2018

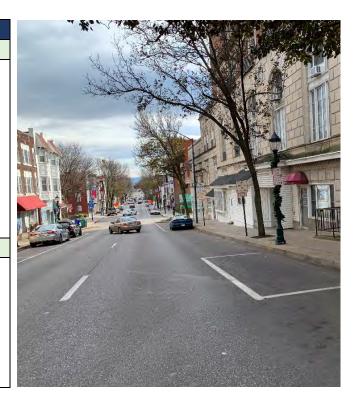
1.1 Downhill East of Potomac Street

Traffic generally follows speed limit, except on the downhill east of the Potomac Street intersection. At the same location, vehicles slow down to turn into a public parking lot

Based on crash data from 2013 to May 2018, 43% of the reported crashes between Potomac St and Locust St were rear end midblock collisions

Evaluate and reconstruct driveway entrances to public parking areas west of Locust Street to enable more fluid entry of vehicles into driveways

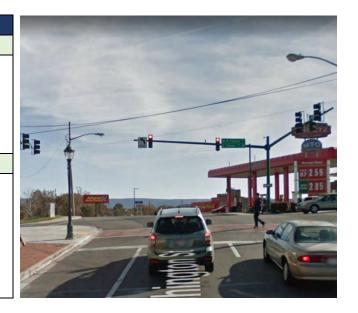
1.2 Cannon Avenue Intersection Approach

Traffic seems to be traveling too fast while approaching the Cannon Ave intersection for the available sight distance through the intersection

Provide signing and pavement marking guidance through the Cannon Ave intersection

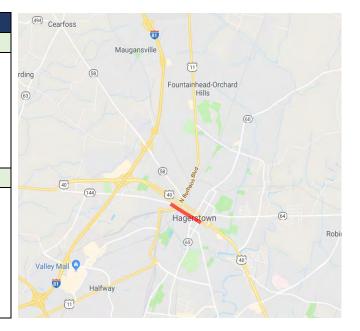
2.1 Incident Diversions Impacting Volumes

Anecdotal evidence suggests traffic volume/congestion is negatively impacted by incident diversions from I-81 and I-70

Improve one way signing and pavement markings for people unfamiliar with the corridor

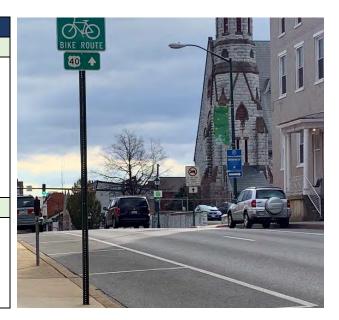
2.2 Parking Spaces

Parking spaces heavily utilized in central section, less so as distance increase from center of town

Based on crash data from 2013 to May 2018, 26% of reported crashes in the study section involved a parked vehicle

Install 10" parking lane pavement marking to emphasize delineation between travel lanes and parking areas

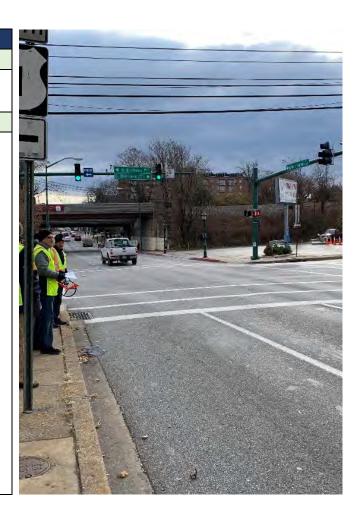
3.1 Traffic Signals

Traffic signals at most intersections along study corridor

- Evaluate all signalized intersections to provide consistent one way and no turn signing at similar intersections
- Investigate restriction of LTOR onto Locust Ave

- Provide backplates on all signal heads
- Evaluate traffic signal timing and confirm yellow and all red clearance interval calculations and implementation
- Consider adding red light cameras at intersections with higher crash rates

- Add pedestrian pushbuttons, heads, and phasing/timing at all intersections where it does not currently exist
- Replace existing 4-section signal heads with 5-section signal heads

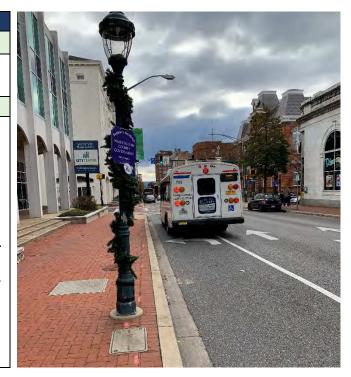
3.2 Vehicles Straddle Lane Lines

Many vehicles straddle lane lines when using turn lanes

- Where possible Eliminate 8' turn lanes and combine turn lane with through lane. Use available space to widen 2 through lanes to 11' lanes with a shoulder. Provide skip lines through intersection as warranted and taper back to meet two 10' receiving through lanes. Provide through and straight/turn arrow pavement marking on newly configured lanes at intersections where warranted. Conduct LOS analysis prior to making lane revisions
- Adjust all signs to reflect recommended lane configuration changes as applicable

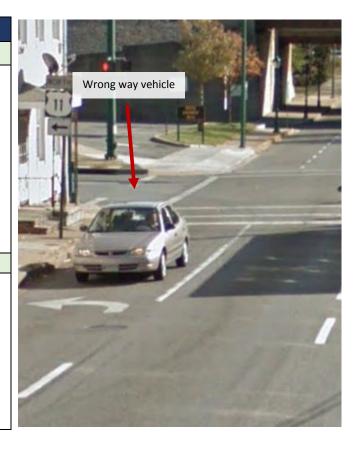
3.3 Wrong Way Driving

Driver observed turning wrong way into one-way traffic during RSA field view

Although a driver was observed turning the wrong way, there have been no reported head-on collisions from 2013 to May 2018

Google maps photos captured a wrong-way driver in 2017 in Washington St. west of Burhans Blvd (shown in photo)

- Evaluate all signalized intersections to provide consistent one way and no turn signing at similar intersections
- Provide thru and straight/turn arrow pavement markings to accentuate and reinforce traffic flow direction at problem intersections

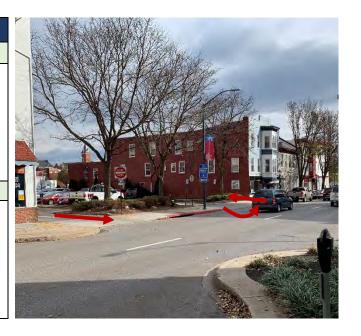
4.1 Public Parking Areas

Extreme slowing observed for vehicles entering newly built driveways into public parking areas

Based on crash data from 2013 to May 2018, 50% of the reported crashes near the parking area driveways were rear end crashes.

Evaluate and reconstruct driveway entrances to public parking areas west of Locust Street to enable more fluid entry of vehicles into driveways

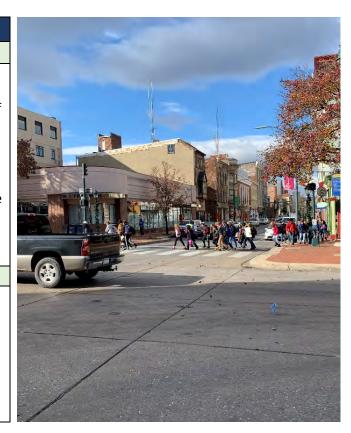
5.1 Typical Urban Section

Typical urban section with expectation of pedestrians at every intersection. Heavy pedestrian use at Potomac intersection because of school children changing classes through intersection. A crossing guard is present at Potomac intersection to assist school children

Based on crash data from 2013 to May 2018, there were 5 pedestrian related crashes and 3 bicycle related crashes within the study corridor. Of those crashes, 75% of them resulted in an injury

- Add pedestrian pushbuttons, heads, and phasing/timing at all intersections where it doesn't currently exist
- Relocate two crosswalks at Potomac St intersection to be closer to corners to improve visibility of pedestrians

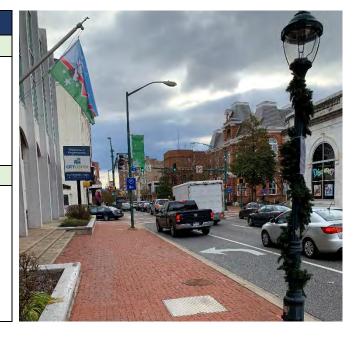
1.1 One-way Corridor

US 40 is a one-way corridor through Hagerstown

Photo of EB US 40/Jonathan St intersection

Evaluate all signalized intersections to provide consistent one way and no-turn signing at similar intersections

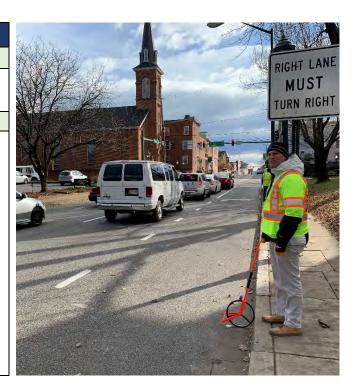
1.2 Pavement Width

36' curb to curb pavement width, less at bulbouts/intersections

- Reconfigure SB approach lanes on Potomac Street north of intersection to combine left turn lane and through lane and thereby provide room to widen through lanes. Conduct LOS analysis prior to lane reconfiguration
- Revise loading zone/parking, turn, and through lanes at Burhans Boulevard intersection (Begin approach lane revisions at Washington Avenue/Antietam Street split)
- Adjust all signs to reflect recommended lane configuration changes as applicable

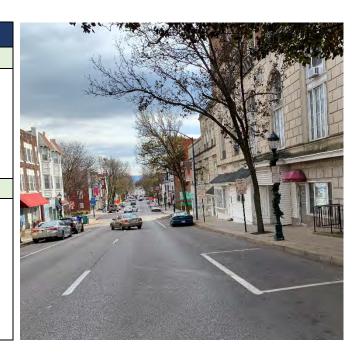
1.3 Midblock Sections

Typical midblock sections are 2-10' travel lanes and 2-8' parking lanes

Photo of downhill section east of US 40/Potomac St intersection showing typical midblock section

Revise lane configurations as suggested per signing and pavement marking recommendations (see Pavement Markings and Signing Recommendations)

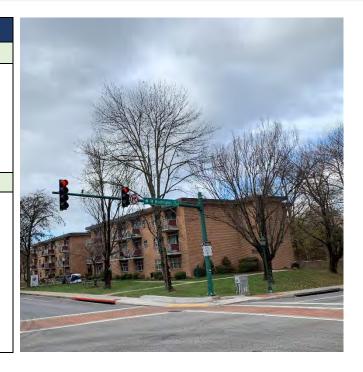
1.5 Painted Crosswalks

Painted crosswalks at signalized intersections

Photo shows the US40/Walnut St intersection, where there are currently no pedestrian pushbuttons or pedestrian signal heads

Add pedestrian pushbuttons, heads, and phasing/timing at all intersections where it doesn't currently exist

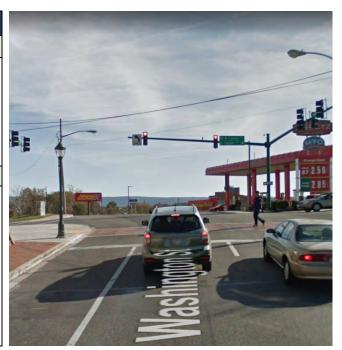
1.6 Sight Distance at Cannon Ave

Sight distance problem/ can't see receiving lanes at Cannon Avenue intersection

Provide signing and pavement marking guidance through the Cannon Ave intersection

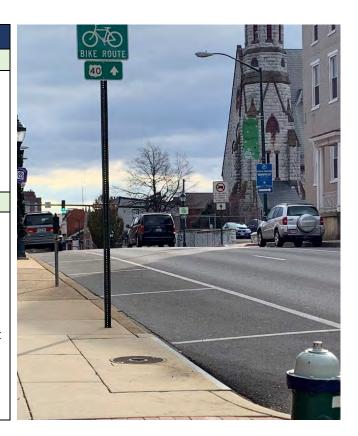
2.1 Metered Parking

Curbside parallel, metered parking is typical throughout the study corridor

Based on crash data from 2013 to May 2018, 26% of reported crashes in the study section involved a parked vehicle

- Revise parking lane edge lines to 10"
- Add triangular/transverse hatching in advance of parking lanes where applicable
- Revise loading zone/parking, turn, and through lanes at Burhans Boulevard intersection (Begin approach lane revisions at Washington Avenue/Antietam Street Split)
- Add and designate a loading zone in front of Washington County Planning and Zoning building west of Jonathan Street
